AIRPROX REPORT No 2021159

Date: 24 Aug 2021 Time: 1320Z Position: 5134N 00017E Location: Upminster

PART A: SUMMARY OF INFORMATION REPORTED TO UKAB

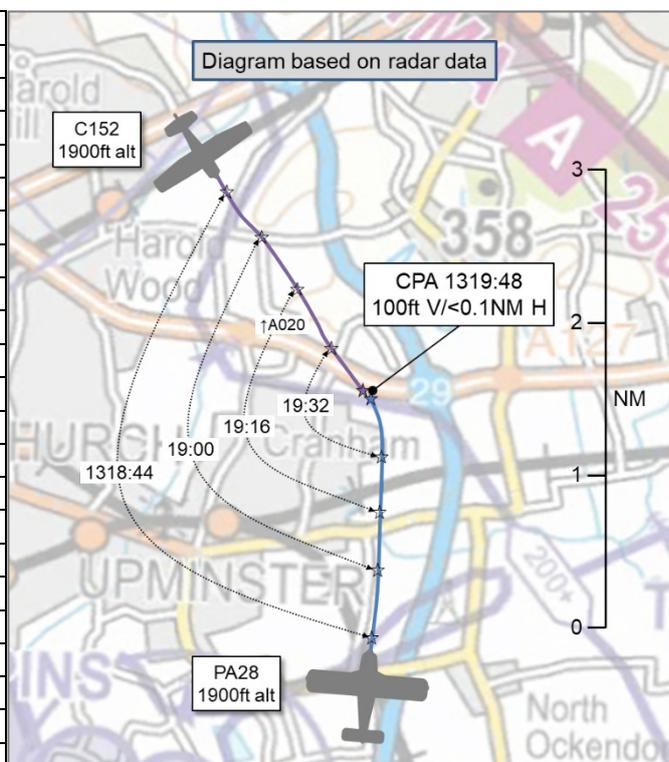
Recorded	Aircraft 1	Aircraft 2
Aircraft	PA28	C152
Operator	Civ FW	Civ FW
Airspace	London FIR	London FIR
Class	G	G
Rules	VFR	VFR
Service	None	Listening Out
Provider	N/A	Southend Radar
Altitude/FL	A019	A020
Transponder	A, C, S	A, C, S
Reported		
Colours	White, yellow	White, red
Lighting	Strobes	Beacon
Conditions	VMC	VMC
Visibility	>10km	>10km
Altitude/FL	1800ft	2000ft
Altimeter	QNH (1030hPa)	QNH (NK hPa)
Heading	020°	180°
Speed	NK	95kt
ACAS/TAS	Not fitted	Not fitted
Separation at CPA		
Reported	150ft V/0.25NM H	NR V/NR H
Recorded	100ft V/<0.1NM H
