**AIRPROX REPORT No 2021040**

Date: 25 Apr 2021 Time: 1156Z Position: 5631N 00243W Location: Carnoustie

**PART A: SUMMARY OF INFORMATION REPORTED TO UKAB**

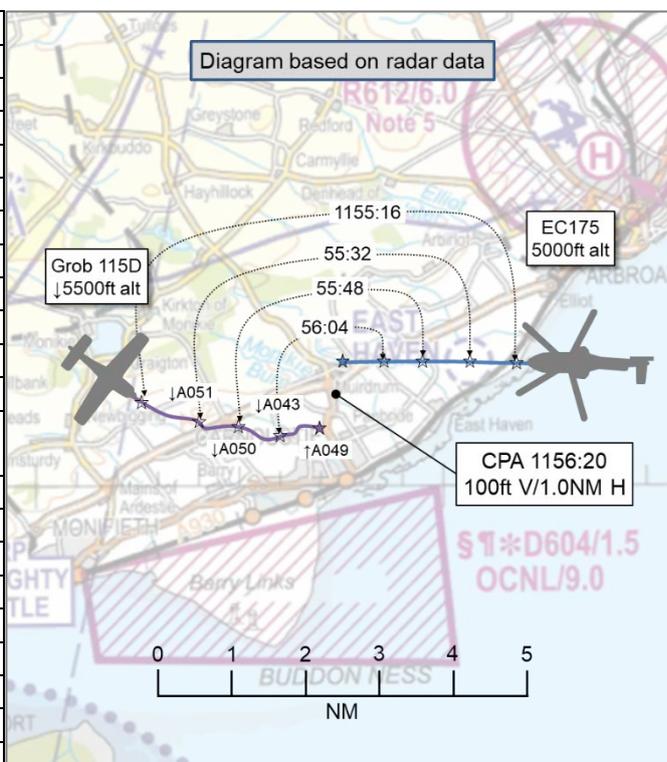
Recorded	Aircraft 1	Aircraft 2
Aircraft	EC175	Grob 115D
Operator	Civ Comm	Civ FW
Airspace	Scottish FIR	Scottish FIR
Class	G	G
Rules	IFR	VFR
Service	Procedural	Basic
Provider	Dundee Approach	Dundee Approach
Altitude/FL	F045	F044
Transponder	A, C, S	A, C, S
Reported		
Colours	Blue/white/gold	White/orange
Lighting	Position, strobe, landing lights	Nav, strobes
Conditions	VMC	VMC
Visibility	>10km	>10km
Altitude/FL	5000ft	>3500ft
Altimeter	QNH (1032hPa)	QNH (1032hPa)
Heading	~270°	090°
Speed	140kt	95kt
ACAS/TAS	TCAS II	Not fitted
Alert	RA	N/A
Separation		
Reported	300ft V/NK H	NK V/1-1.5NM H
Recorded	100ft V/1.0NM H
