AIRPROX REPORT No 2022063

Date: 30 Apr 2022 Time: 1419Z Position: 5347N 00111W Location: Sherburn-in-Elmet ATZ

PART A: SUMMARY OF INFORMATION REPORTED TO UKAB

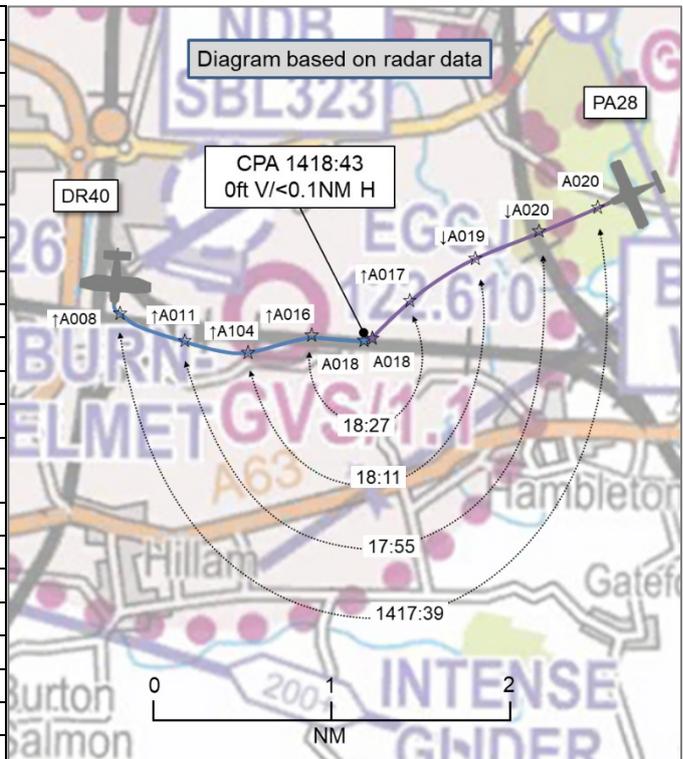
An analysis of the NATS radar replay was undertaken and both of the aircraft involved in the Airprox had been detected and identified using SSR Mode-S, along with the TB10 mentioned in the DR40 pilot's report. In the radar screenshots below, the Mode-C of the aircraft is displayed as a flight level, therefore, due to the conditions on the day, 400ft should be added to obtain aircraft altitude.
