AIRPROX REPORT No 2022083

Date: 12 May 2022 Time: 1225Z Position: 5204N 00032W Location: 3NM E Cranfield airfield

PART A: SUMMARY OF INFORMATION REPORTED TO UKAB

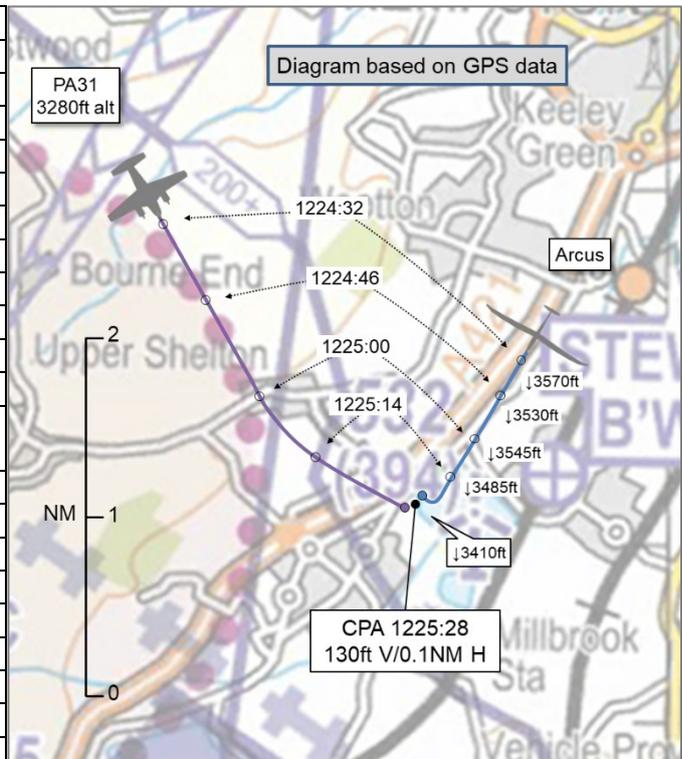
[The PA31 pilot] initiated a left turn and a primary contact was observed on radar to track southwest in close proximity at 1225:30 (See Figure 1) approximately 2.8NM east of Cranfield.
