AIRPROX REPORT No 2022079

Date: 08 May 2022 Time: 1521Z Position: 5219N 00020W Location: Kimbolton

PART A: SUMMARY OF INFORMATION REPORTED TO UKAB

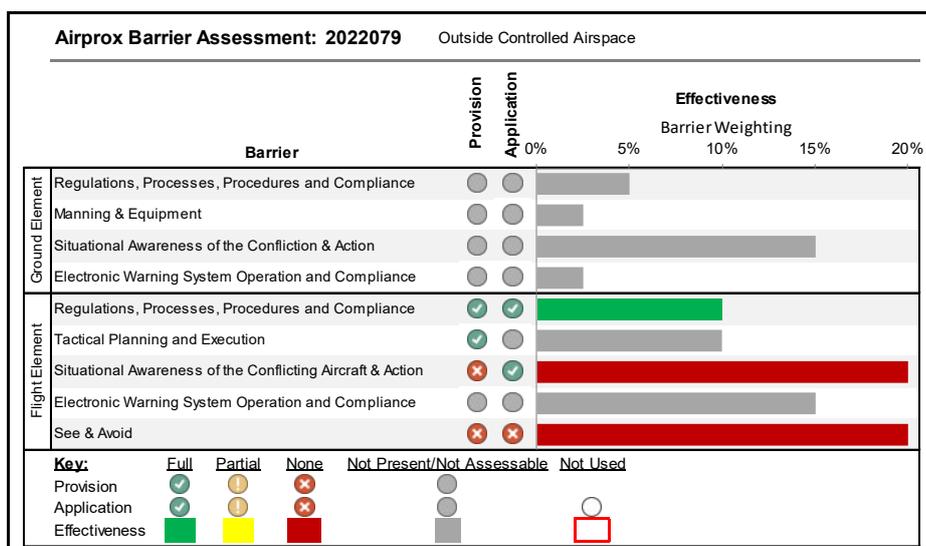
Safety Barrier Assessment⁴

In assessing the effectiveness of the safety barriers associated with this incident, the Board concluded that the key factors had been that:

Situational Awareness of the Conflicting Aircraft and Action were assessed as **ineffective** because the C150 pilot had had only generic information that there were gliders operating in the area, but not specific information on the Airprox glider.

See and Avoid were assessed as **ineffective** because the C150 pilot had not seen the glider in time to take any avoiding action.
