AIRPROX REPORT No 2022095

Date: 01 Jun 2022 Time: 1101Z Position: 5048N 00041W Location: Bognor Regis

PART A: SUMMARY OF INFORMATION REPORTED TO UKAB

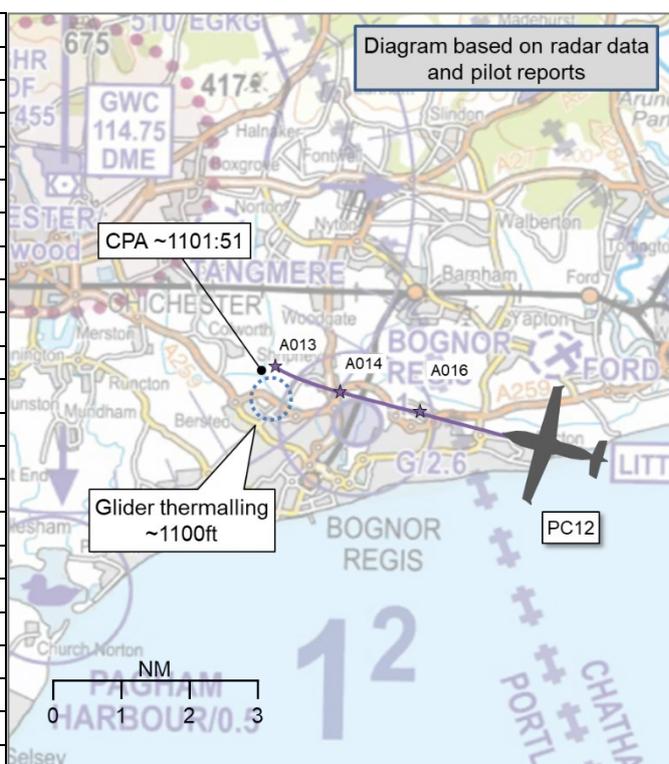
THE DG1001 PILOT reports that they saw the PC12 on a westerly heading. As they were to the west of the club in a thermal, and had been there for approximately one minute, they believed that the PC12 had overflowed the club prior to the event. They saw it turn towards Goodwood and couldn't change to the Goodwood frequency and so called Goodwood Tower directly on their phone. They had lost sight of the PC12 as the orbit continued and they assessed that due to the orbit they were not on a collision course. As they turned through further 120° they saw it again heading away from them. They believe that the PC12 flew directly over the glider site at 1100ft and it was lucky that they weren't winch launching at the time. Goodwood should be aware of the launch activity and should pass information on to inbound pilots. The pilot re-called Goodwood after the flight and Goodwood claimed not to know about the operation, however, they should be aware of regular glider flying on Wednesdays. The Goodwood AFISO said that the PC12 pilot had mentioned that they might get a call from a glider pilot, so they assumed that the PC12 pilot had mentioned the event to the AFISO on the radio.

THE PC12 PILOT reports that they were flying an IFR filed flight and were transitioning to a VFR approach and landing. As they approached Bognor they could see a glider which they believe launched from the old LEC runway. To maintain visual contact, they carried on with their course and altitude and at no time did they feel it necessary to take avoiding action. It was in uncontrolled airspace so obviously it was up to the individual pilots to maintain a good lookout. They had a collision warning system (CWS) on the aircraft but clearly, as the glider didn't have a transponder, it could not detect the glider. They noted that the area was generally quite busy with general aviation traffic so a good scan was essential. Goodwood aerodrome provides a Basic Flight Information Service to all aircraft who are flying from the airfield or who are transiting the general area. However, this only applies to aircraft that call up on frequency and let Goodwood know their intentions. They opined that it would be good practice for any glider pilots launching from the Bognor site to give Goodwood a call before launch to give a basic

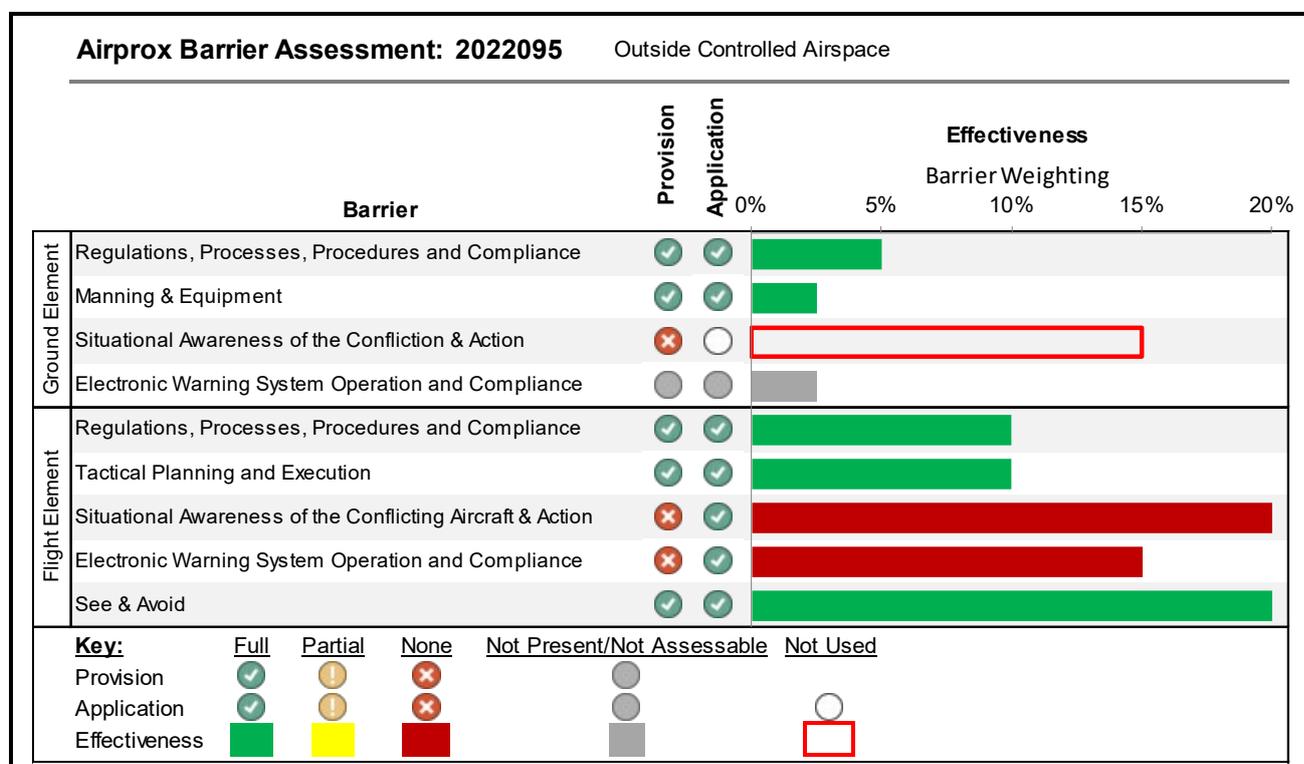
Situational Awareness of the Conflicting Aircraft and Action were assessed as **ineffective** because neither pilot had been aware that the other aircraft was in the vicinity.

Electronic Warning System Operation and Compliance were assessed as **ineffective** because the EC equipment on the two aircraft was not compatible.
