AIRPROX REPORT No 2022102

Date: 12 Jun 2022 Time: 1451Z Position: 5249N 00143W Location: Tatenhill ATZ

PART A: SUMMARY OF INFORMATION REPORTED TO UKAB

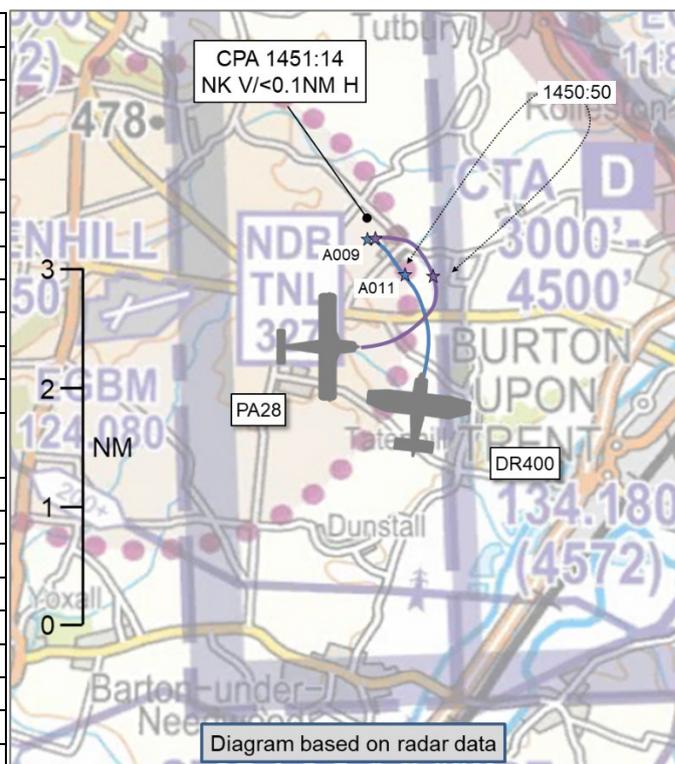
Recorded	Aircraft 1	Aircraft 2
Aircraft	DR400	PA28
Operator	Civ FW	Civ FW
Airspace	Tatenhill ATZ	Tatenhill ATZ
Class	G	G
Rules	VFR	VFR
Service	AGCS	AGCS
Provider	Tatenhill Radio	Tatenhill Radio
Altitude/FL	900ft	NK
Transponder	A, C, S	A, S ¹
Reported		
Colours	White, red	White, blue
Lighting	Nav, Strobes, Landing	Nav, Beacon, Landing
Conditions	VMC	VMC
Visibility	>10km	>10km
Altitude/FL	700ft	700ft
Altimeter	QFE (1009hPa)	QFE
Heading	260°	287°
Speed	70kt	75kt
ACAS/TAS	PilotAware	PilotAware
Alert	None	Information
Separation at CPA		
Reported	0ft V/100m H	50ft V/30m H
Recorded	NK V/<0.1NM H

THE DR400 PILOT reports that they were aware of a C172 joining ahead and made a radio call as they commenced a dead-side descent with [the C172] in front. They followed [the C172] downwind, and made a late downwind call due to other radio chatter. [A PA28] also made a downwind call and stated that they were in contact with [DR400 C/S] ahead. [The C172] made quite a wide circuit, which [the DR400 pilot] conformed to. The downwind leg was extended slightly to allow greater separation with [the C172] in front as they knew that they would be faster on final. On base leg, another aircraft passed in front of [the DR400] from left-to-right at the same level. At this stage, they were unaware that it was [the PA28] behind that was cutting in. Upon reaching the turning point from base-leg to final, [the PA28] was still flying away off their right-wing. [The DR400 pilot] turned on to final. [The DR400 pilot] then noticed [the PA28] turning left and, having overshot the runway centre, was flying on a converging course with [the DR400] to re-establish itself on final for RW26. During this turn, the pilot of [the PA28] called "final" on the radio. At this point, urgent avoidance action was necessary to prevent a collision. [The DR400 pilot] was uncertain whether there was another aircraft on downwind, so concluded that turning left was not a safe option. [The PA28] was quickly closing from the right. [The DR400] pilot considered that the only option would have been a rapid change of altitude but instead, made a radio call and stated that another aircraft had just cut in front and asked the other aircraft to turn. [The PA28] pilot responded immediately and turned [to the right]. [The DR400 pilot] estimates that without action, a collision would have occurred in less than 10sec. The remainder of the approach and landing was uneventful.

THE PA28 PILOT reports that, as they were unfamiliar with [the destination airfield], they had made contact before departure to obtain PPR and to confirm the expected joining procedure. On joining [destination airfield], they noticed an aircraft on a converging course also joining. They noted the [DR400] callsign on the radio and with reference to [EC device], determined that this was most likely the aircraft they were visual with. Because they had not visited this airfield before, they decided to slow down and modify their track to follow the joining traffic. They followed this aircraft during the deadside descent, and crosswind, and continued downwind, still visual with and following an aircraft. [The PA28 pilot] extended the downwind leg to maintain separation. Whilst flying downwind, they noticed another aircraft at about 30° to their right but disregarded it as it appeared to be outside the ATZ. Towards the end of their turn from base-leg to final, the [DR400 pilot] called on the radio claiming to have been cut up and yelling for [the PA28 pilot] to take avoiding action.

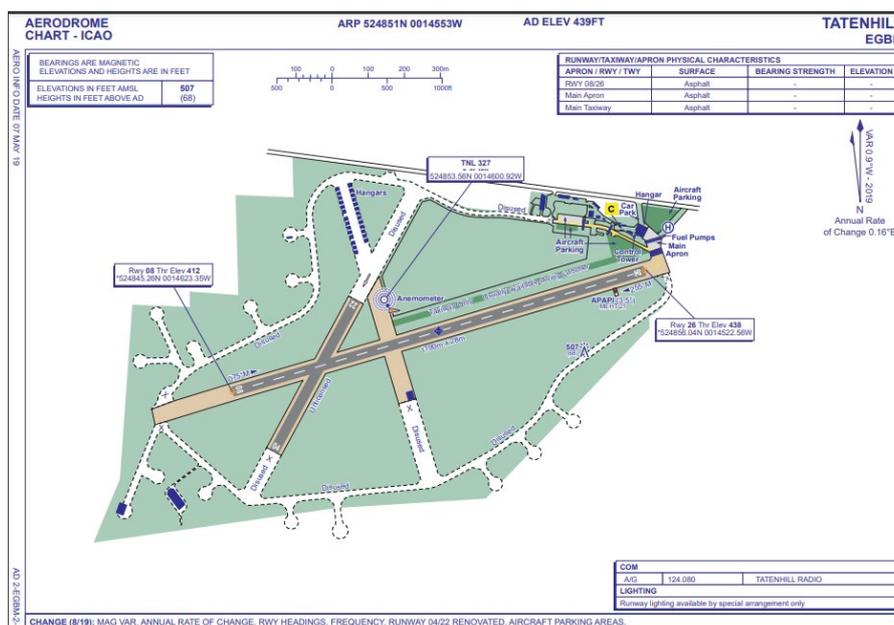
The UK AIP entry for Tatenhill is reproduced below:

EGBM AD 2.22 FLIGHT PROCEDURES

1 CIRCUITS

- a. Aircraft to make standard overhead join. Circuits are left hand for Runways 08 and 26.

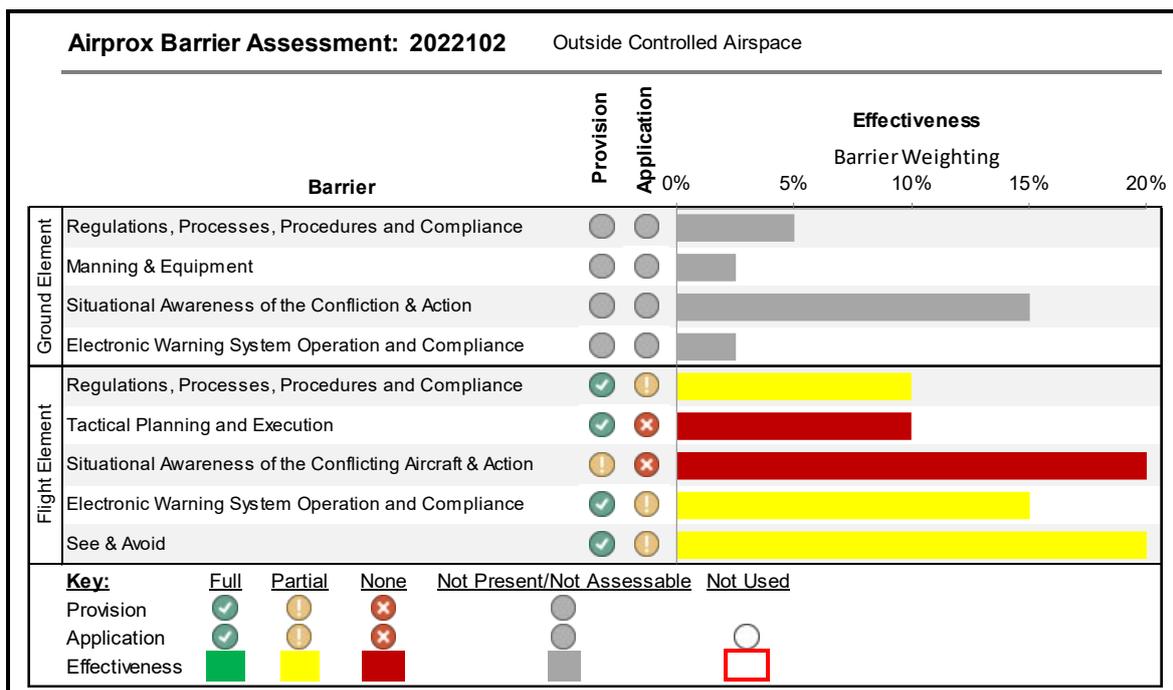
Electronic Warning System Operation and Compliance were assessed as **partially effective** because although the PA28 had information from their EC equipment, they did not use it to confirm the position of the DR400, and although an alert would be expected on the DR400, none was received.

See and Avoid were assessed as **partially effective** because it was a late sighting by both pilots.
