AIRPROX REPORT No 2022163

Date: 07 Aug 2022 Time: 1510Z Position: 5225N 00017W Location: 2NM SW Conington

PART A: SUMMARY OF INFORMATION REPORTED TO UKAB

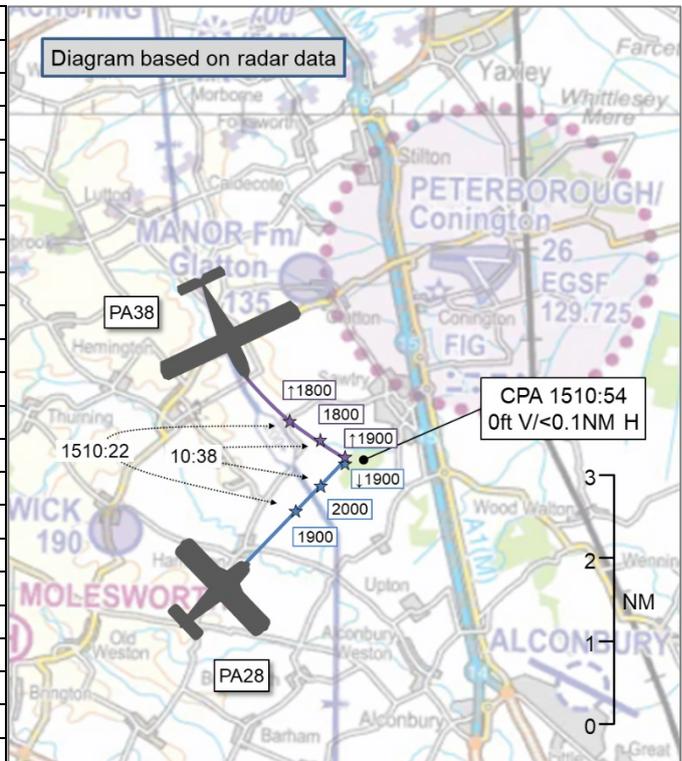
Recorded	Aircraft 1	Aircraft 2
Aircraft	PA28	PA38
Operator	Civ FW	Civ FW
Airspace	London FIR	London FIR
Class	G	G
Rules	VFR	VFR
Service	AGCS	None
Provider	Conington	
Altitude/FL	FL016	FL016
Transponder	A, C, S	A, C, S
Reported		
Colours	Blue, White	White, Blue
Lighting	None	Strobe, Nav
Conditions	VMC	VMC
Visibility	>10km	>10km
Altitude/FL	2700ft	2150ft
Altimeter	QFE (1025hPa)	QNH
Heading	035°	110°
Speed	95kt	80kt
ACAS/TAS	Not fitted	Not fitted
Separation at CPA		
Reported	0ft V/30-60m H	0ft V/ NK H
Recorded	0ft V/<0.1NM H
