AIRPROX REPORT No 2022178

Date: 16 Aug 2022 Time: 1029Z Position: 5300N 00107E Location: 4NM NE Blakeney Point

PART A: SUMMARY OF INFORMATION REPORTED TO UKAB

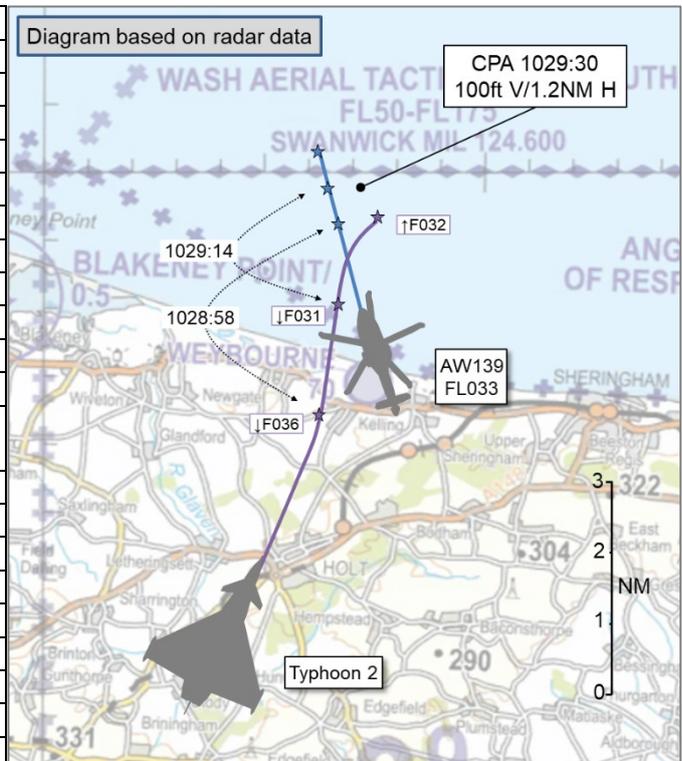
Recorded	Aircraft 1	Aircraft 2
Aircraft	AW139	Typhoon
Operator	Civ Comm	HQ Air (Ops)
Airspace	London FIR	London FIR
Class	G	G
Rules	IFR	VFR
Service	Traffic	Traffic
Provider	Norwich	Swanwick(Mil)
Altitude/FL	FL033	FL032
Transponder	A, C, S	A, C, S
Reported		
Colours	Blue, White, Red	Grey
Lighting	Anti-col, Position, Searchlight	NR
Conditions	IMC	VMC
Visibility	5-10km	5-10km
Altitude/FL	3000ft	3000ft
Altimeter	QNH (1003hPa)	RPS (1002hPa)
Heading	350°	NR
Speed	140kt	330kt
ACAS/TAS	TCAS I	Not fitted
Alert	TA	N/A
Separation at CPA		
Reported	75ft V/1.38NM H	NR
Recorded	100ft V/1.2NM H
