AIRPROX REPORT No 2022197

Date: 26 Aug 2022 Time: 0943Z Position: 5150N 00142W Location: 2.5NM S Little Rissington

PART A: SUMMARY OF INFORMATION REPORTED TO UKAB

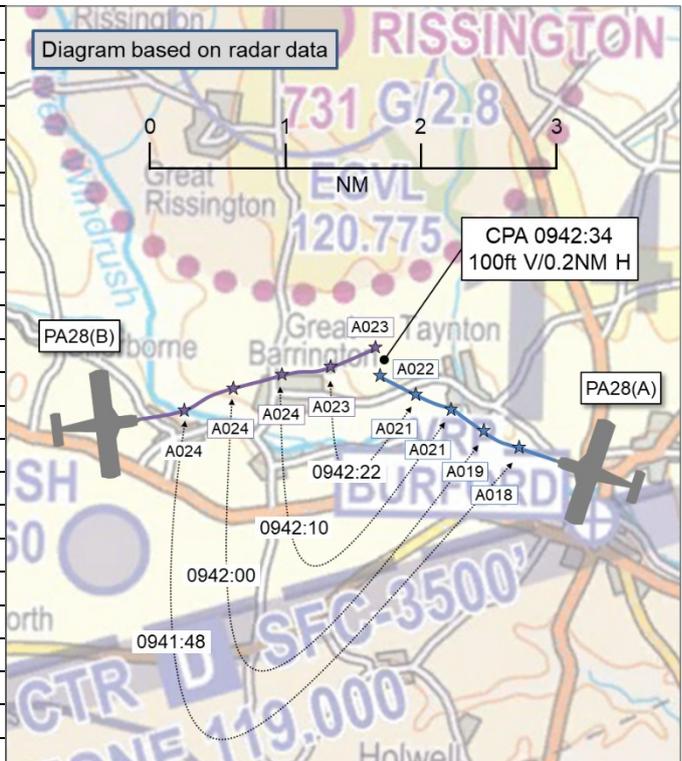
THE PA28(A) PILOT reports that they were climbing to cruise altitude (with a nose-high attitude) when Brize Zone advised them of a confliction 1NM west, “slightly above” [they recall] and opposite direction. At about the same time, they saw the other aircraft in a 30-40° left angle-of-bank attitude (avoiding action), and it then reverted back to its original course. There was no time to take avoiding action before [the other aircraft] had passed down their right side and disappeared. They believe that [the other aircraft] had been in their blind area (below their engine) and had the Brize controller not drawn their attention to the contact, there was a significant chance of a collision.

THE PA28(B) PILOT reports that they were flying en-route to [destination airfield]. Weather and visibility were good. They were in communication with Brize (and don’t believe that the other aircraft was on frequency). Their TAS threw up an alert of an aircraft possibly 6NM to their right, 1000ft lower and climbing. They kept an eye on this contact and turned on their landing light and executed a turn to the left to show their wings, and then levelled-out. On doing so, they briefly saw the [other] aircraft pass behind, left-to-right [they recall] and in a climb. They resumed heading and landed safely at [destination airfield]. Brize called them up a few minutes later to ask if they had seen the passing aircraft and they replied that their TAS had indicated 1000ft below and that it had passed behind them. The PA28(B) pilot recalls that they were not unduly concerned as they had the aircraft under observation throughout. They are pretty sure that the [pilot of the PA28(A)] should have seen them sooner as the sun had been behind them and the [PA28(B)] was higher so should have been silhouetted and easy to spot.

An Airprox was reported when PA28(A) and PA28(B) flew into proximity 2.5NM south of Little Rissington at 0943Z on Friday 26th August 2022. Both pilots were operating under VFR in VMC, the PA28(A) pilot in receipt of a Basic Service from Brize Approach and the PA28(B) pilot in receipt of a Basic Service from Brize Radar.
