AIRPROX REPORT No 2022204

Date: 19 Aug 2022 Time: 1342Z Position: 5356N 00114W Location: 1.5NM SW Rufforth

PART A: SUMMARY OF INFORMATION REPORTED TO UKAB

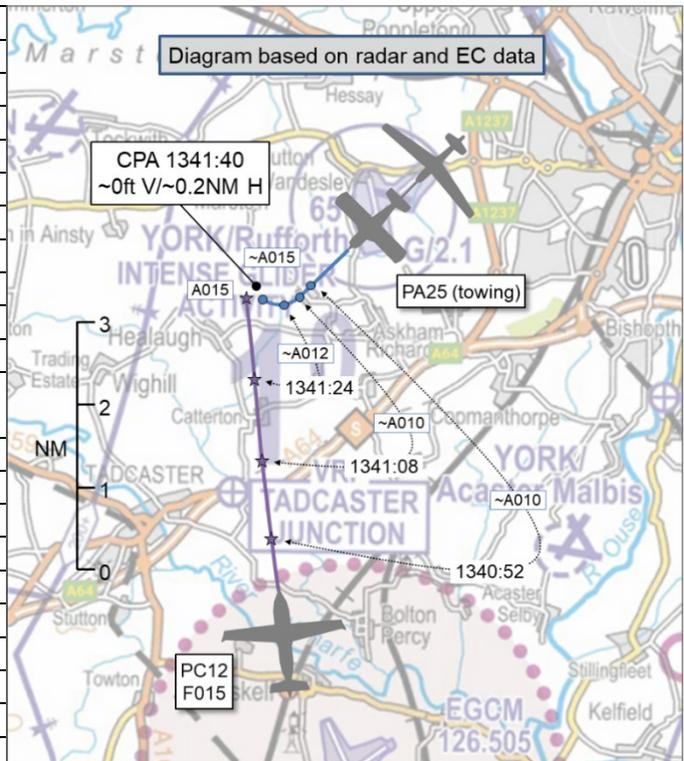
THE PA25 PILOT reports that while towing an ASK13 glider, heading west from Rufforth and climbing through approximately 1700/1800ft (Rufforth QFE), they became quickly aware of traffic identified as a PC12 crossing their path from left-to-right about 100m ahead, and at their altitude. As avoiding action, they turned immediately right (with the glider in tow), the PC12 took a hard turn left before continuing a northerly heading. [The PA25 pilot] turned back to a westerly heading and continued the tow.

THE ASK13 PILOT [of the glider being towed] reports that no more than 5min into the aero-tow the combination was subject to an Airprox involving a predominantly white coloured Pilatus PC12 which crossed in front of the combination at no more than 100m range at the same altitude. The combination was heading west and the PC12 was heading north, flying level. It took avoiding action by banking to port and the tug aircraft turned to starboard. The PC12's registration was not visible as it banked and it was travelling at high speed compared to the tug which climbs at only 65kts.

THE PC12 PILOT reports that no avoiding action was taken as [it had been] unnecessary, but they made a steep bank away to show the other aircraft their profile. The other pilot may have mistaken this as avoiding action. [The other pilot] did not appear to manoeuvre which may have been due to the fact that [they hadn't] seen the [PC12] until the [PC12 pilot] had made the initial manoeuvre.
