AIRPROX REPORT No 2022208

Date: 06 Sep 2022 Time: 1040Z Position: 5329N 00221W Location: Manchester Barton ATZ

PART A: SUMMARY OF INFORMATION REPORTED TO UKAB

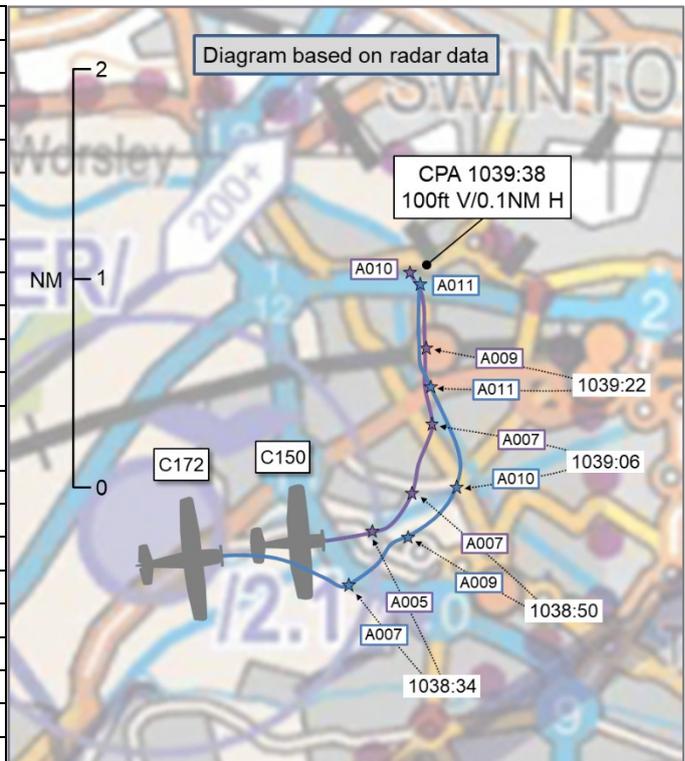
Recorded	Aircraft 1	Aircraft 2
Aircraft	C172	C150
Operator	Civ FW	Civ FW
Airspace	Barton ATZ	Barton ATZ
Class	G	G
Rules	VFR	VFR
Service	AFIS	AFIS
Provider	Barton Information	Barton Information
Altitude/FL	1100ft	1000ft
Transponder	A, C, S	A, C, S
Reported		
Colours	White, yellow, blue	Red, white
Lighting	Landing, taxi, nav, strobes, beacon	Beacon, landing, nav
Conditions	VMC	VMC
Visibility	5-10km	5-10km
Altitude/FL	1000ft	NK
Altimeter	QFE (NR hPa)	QFE (1009 hPa)
Heading	350°	350°
Speed	110kt	65kt
ACAS/TAS	Not fitted	Not fitted
Separation at CPA		
Reported	75ft V/0NM H	100ft V/100m H
Recorded	100ft V/0.1NM H
