## AIRPROX REPORT No 2022240

Date: 11 Oct 2022 Time: 0820Z Position: 5150N 00117W Location: Oxford ATZ

### PART A: SUMMARY OF INFORMATION REPORTED TO UKAB

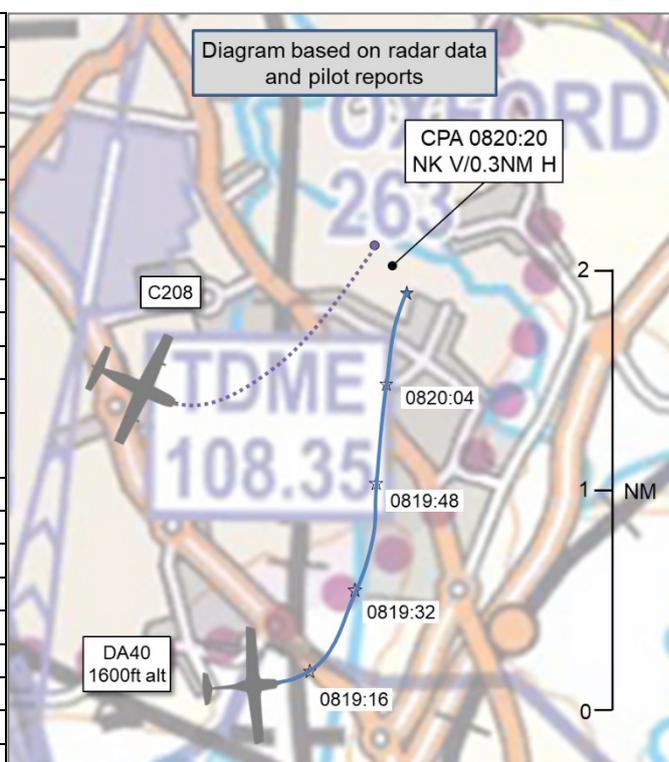
An analysis of the NATS radar replay was undertaken and the DA40 was detected and identified using Mode S data. There was no secondary radar return detected from the C208, however a primary return appeared on the radar one sweep before the orbit carried out by the DA40 pilot was observed, therefore it is likely that this primary return was generated by the C208, Figure 1.
