## AIRPROX REPORT No 2022251

Date: 18 Oct 2022 Time: 1422Z Position: 5111N 00039E Location: Lashenden/Headcorn ATZ

### PART A: SUMMARY OF INFORMATION REPORTED TO UKAB

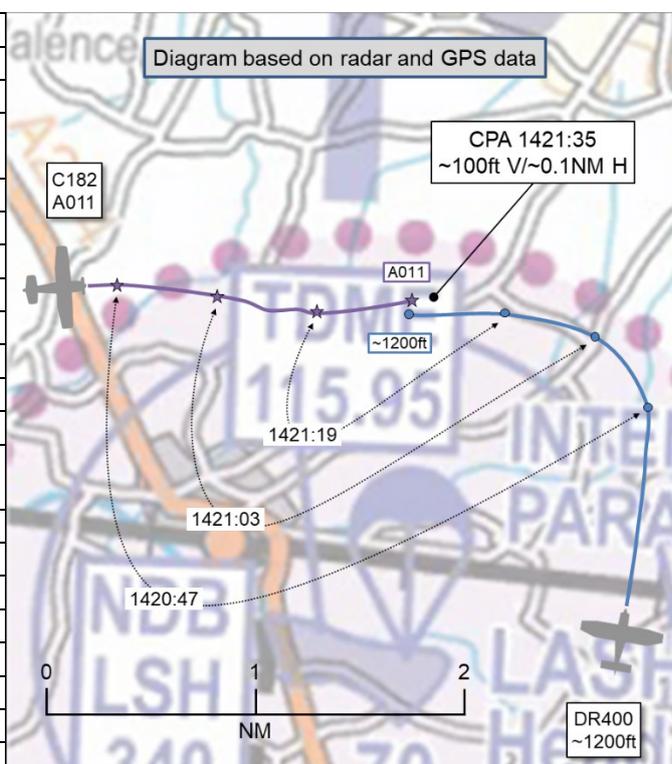
An analysis of the NATS radar replay was undertaken and the C182 was identified from Mode S data (see Figure 2). The DR400 was not observed on radar, even as a primary return. The pilot of the DR400 kindly supplied a GPS data file of their track. It was with these separate sources that the diagram was constructed and the separation at CPA assessed.
