ASSESSMENT SUMMARY SHEET FOR UKAB MEETING ON 14 SEPTEMBER 2011

AIRPROX REPORT No 2011024

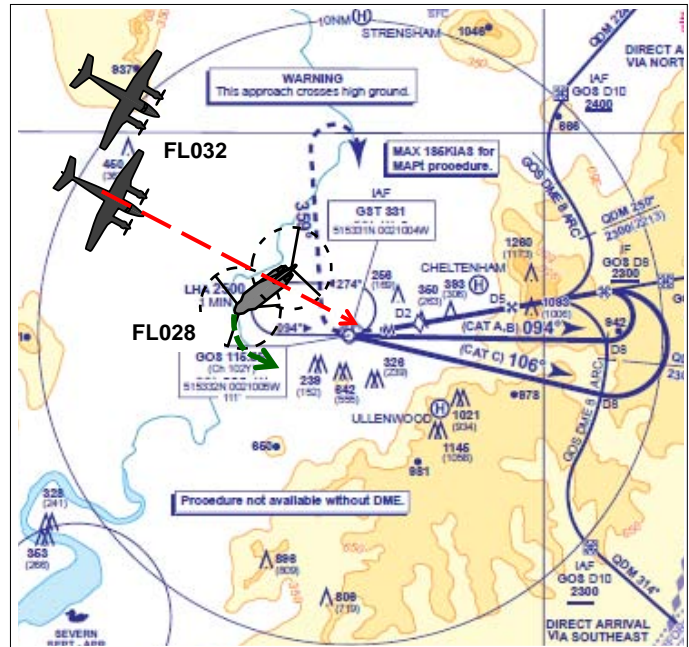
Recorded Separation:

400ft V/ 0.1nm H

THE CHINOOK PILOT reports flying an IFR approach to Gloucestershire on a training flight in receipt of a BS from them, squawking 7000 with Mode C and S in a green ac with all appropriate lights switched on but TCAS was not fitted. While established in the GST NDB hold for RW27 at 3000ft, heading 274° at 120kt, on the Gloucestershire QNH of 1021mb, a two-ship [blue and white, military] King Air formation flew over the top of their ac in straight and level flight. They were spotted initially by the HP and then the Crewman, shortly before they flew O/H and they were estimated to be less than 200ft above the ac. They tightened their left hand turn to avoid them and reported the incident on landing, assessing the risk as being high.

Cause: The Chinook crew was concerned by the proximity of the King Air formation.

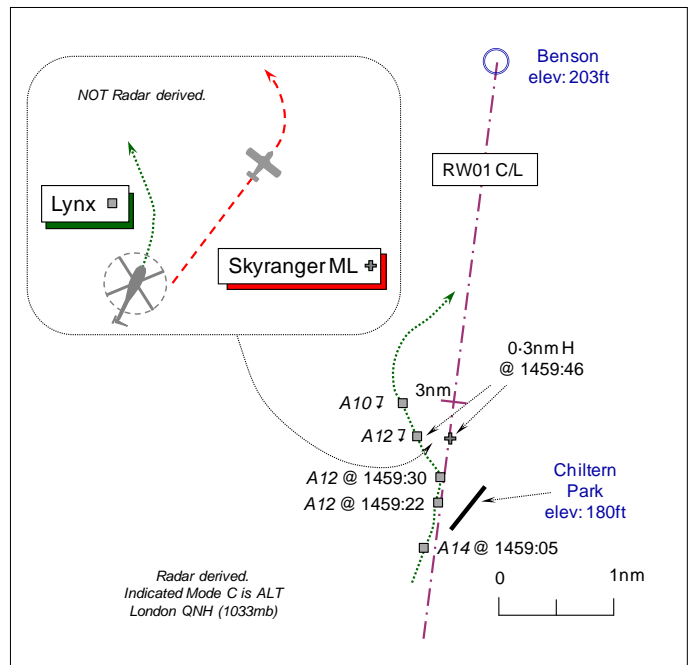
Recorded Separation:

Not recorded

THE WESTLAND LYNX AH Mk7 PILOT reports flying a training sortie from Odiham and was conducting an SRA at Benson to RW01RHC in VMC. He was in receipt of a TS from Benson TALKDOWN (TD) on 277.675MHz. A squawk of A3617 was selected with Mode C; neither Mode S nor TCAS is fitted.

THE BENSON TALKDOWN CONTROLLER (TD) reports he was conducting a SRA to RW 01RH for the Lynx AH Mk7. The meteorological conditions were good - sfc wind 040°/8kt, 25km visibility and FEW cloud at 3800ft. As the ac was approaching the 4nm point he noticed a primary radar return that had just 'painted' to the E of the centreline at the 3½nm point. Immediately, he called the radar return to the Lynx pilot as, in his judgement, it indicated that the primary return could be an ac climbing out of Chiltern Park, situated to the S of Benson A/D. The Lynx pilot did not call visual at that point; in the controller's view, as the unknown ac turned straight towards the Lynx on the centreline at the 3½nm point, there was a definite risk of collision. Avoiding action was given to the Lynx pilot of a L turn onto a heading of 330° to ensure that the risk of collision would be avoided. The Lynx pilot then called visual with the unknown ac and he was then able to continue with the SRA and complete the approach.

Cause: Conflict in Class G airspace resolved by the Talkdown Controller.

Consequently a recommendation has been made to the MAA Op Gp – ATM Division – relating to a review of JSP 552 405.135.20 and JSP 552 405.125 and the provision of additional guidance; a reply is awaited.

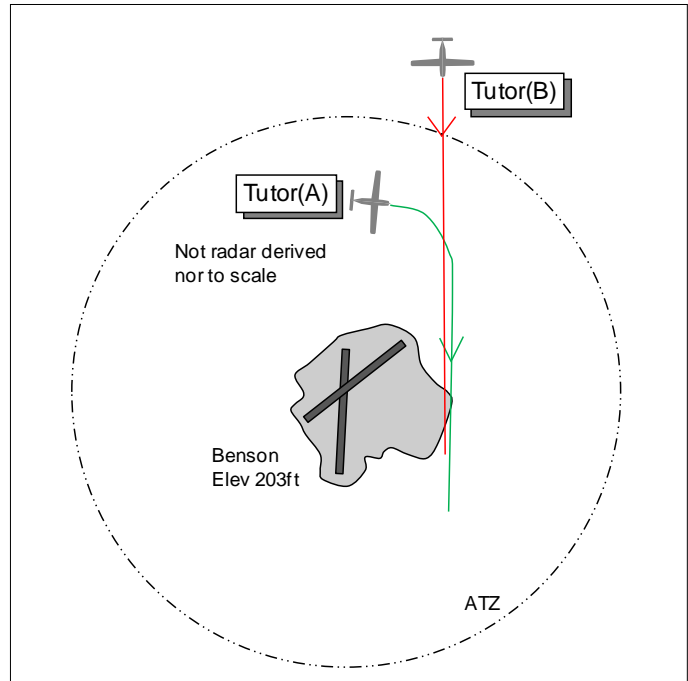
Recorded Separation:

NR

THE TUTOR(A) PILOT reports flying a solo cct consolidation exercise at Benson, VFR and in communication with Benson Tower on 127.15MHz; the ac's transponder was switched off. The visibility was 10km below cloud in VMC and the ac was coloured white with HISLs and nav lights switched on. He was late making a downwind call on RW01 because when he was ready, about a third of the way down the RW, he was unable to call owing to other traffic communicating with ATC. Heading 190° at 800ft QFE and 80kt he made a routine lookout to the R, by now he was two-thirds of the way down the RW, he noticed another Tutor, Tutor(B), about 100ft higher and 150ft away in his 4 o'clock. He believed that both he and the Tutor(B)'s pilot saw each other at the same time because the other Tutor initially broke R as its pilot called ATC before then conducting a LH orbit. During this period he maintained straight and level flight and watched to see what Tutor(B) was doing. Once Tutor(B) was clear he was able to call "downwind" and was cleared for a touch and go after another Tutor, Tutor(C) that was already on final. He assessed the risk as high.

Cause: In the absence of specific TI, Tutor(B) crew conducted a non-standard join and did not integrate safely into the cct pattern.

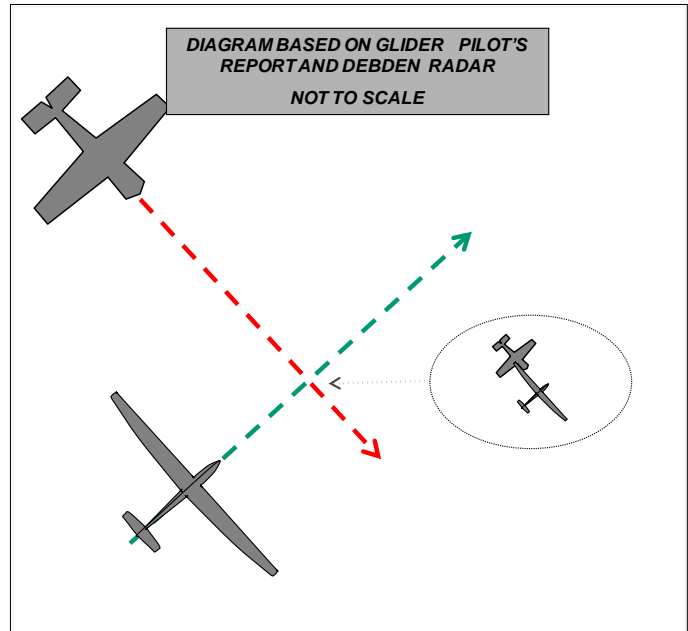
Recorded Separation:

NR

THE DISCUS 15M GLIDER PILOT reports soaring at 70kt in a white single-seat glider with orange hi-visibility flashes on the wings and fin. He was 7nm SW of Sywell and listening out on a gliding common frequency when he had a close encounter at 4300ft (QNH) with a single-engine GA ac, believed to be low wing or mid-wing configuration, mostly white with some blue and possibly a yellow flash [actually silver with a yellow band]; the registration was not seen. He was not equipped with SSR or TCAS; FLARM was fitted and serviceable but did not indicate any contacts.

Cause: A non-sighting by the Harvard pilot and effectively a non-sighting by the Discus pilot.

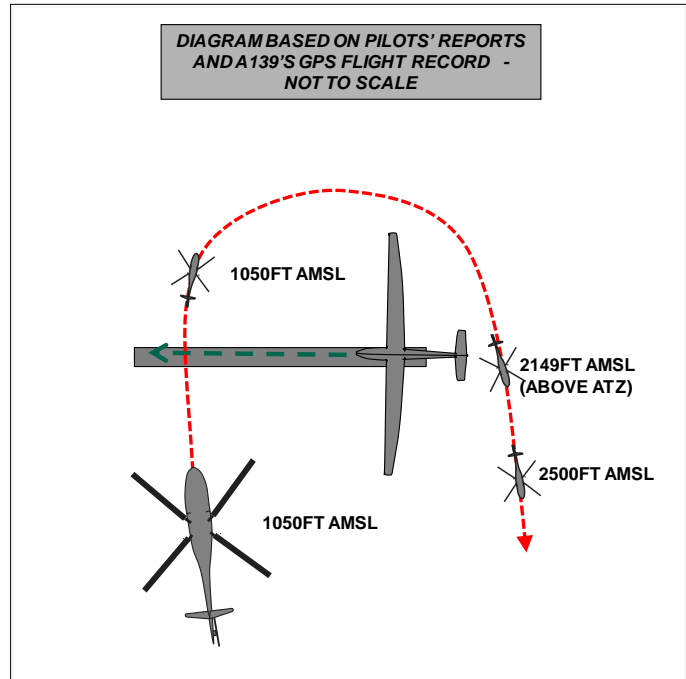
Recorded Separation:

Est 800ft V/NR H

THE PUCHACZ GLIDER PILOT reports flying the second of two check flights for the handling pilot in a white glider listening out on the [unmanned] TWR VHF frequency [120.8]. The ac was launched by wire auto-tow from RW27 and they were in the initial climb at about 300ft and 55kt when the instructor aborted the launch to simulate a launch failure/cable break. As the handling pilot lowered the nose of the glider a red and white helicopter was seen in their 11 o'clock position heading slightly towards them, crossing from L to R. The instructor took control and commenced a descent to land straight ahead. The helicopter maintained its height of about 1500ft and turned about 030° left crossing ahead of them before turning R on the N side of airfield over the technical site. Thereafter, the helicopter turned R and flew away from the airfield to the SE.

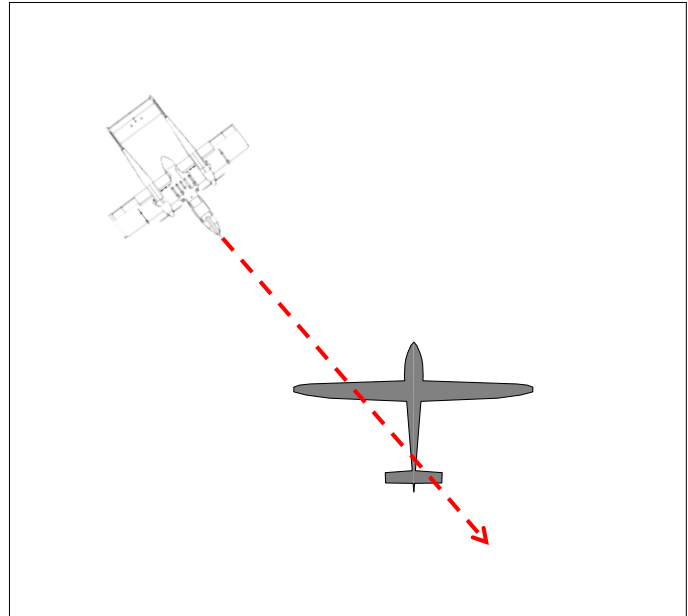
Recorded Separation:

NK

THE VENTUS GLIDER PILOT reports soaring at 50kt on the Marham QFE of 1020mb [see UKAB Note (1)] in dark, overcast conditions in a white glider with no SSR fitted but listening out on Marham Ground when he saw a dark camouflage green, twin tail boom Bronco type ac with day glo panels, ½ nm away and approaching him. He rocked the wings of his ac to attract attention of the other pilot and then flew away from the other ac.

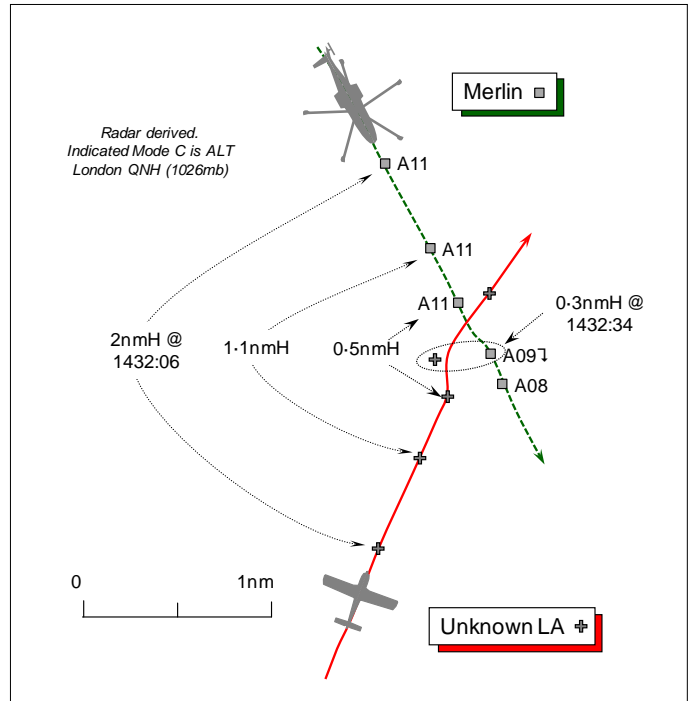
Recorded Separation:

<0.3nmH – See UKAB Note (1)

THE MERLIN HC3 HELICOPTER PILOT, a QHI, reports he was conducting a conversion training sortie and was in transit under VFR from Linton-on-Ouse to Benson, whilst monitoring the LFS frequency. He was not under an ATIS; a squawk of A7000 was selected with Mode C; neither TCAS nor Mode S is fitted.

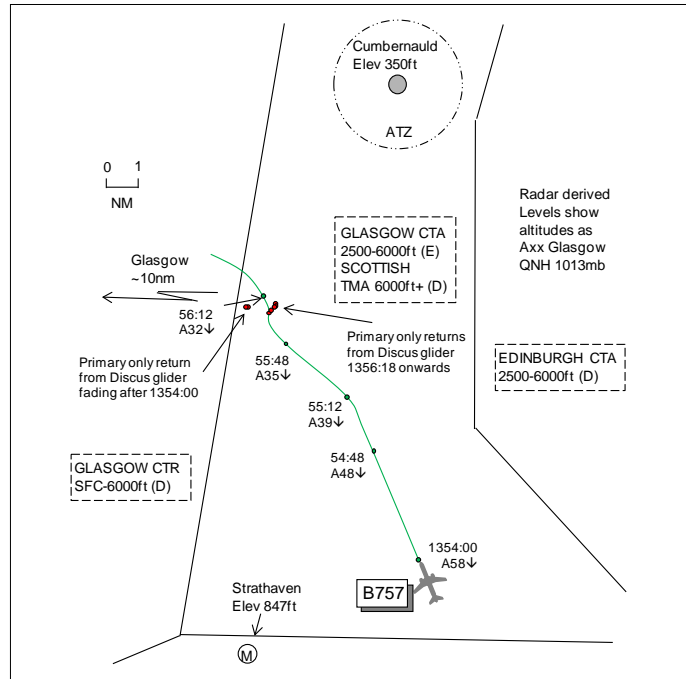
Recorded Separation:

NR

THE B757 PILOT reports inbound to Glasgow IFR and in receipt of a RCS from Glasgow Approach on 128.75MHz, squawking 2746 with Modes S and C. They were operating in excellent visibility below scattered cloud and had requested and received clearance for a visual approach but not to descend below 3000ft. Radar had advised that a primary return had been seen in the area previously but had now disappeared, having believed that the ac had descended below radar cover. About 12nm SE Glasgow heading 300° at 230kt, level at 3000ft, he thought, he saw a glider directly ahead range 1.5nm and at the same level. The A/P was disconnected and a R turn was commenced. The glider appeared to fly straight and level in the opposite direction passing 100m to their L at the CPA. ATC was informed and the approach was continued normally. He assessed the risk as high.
