AIRPROX REPORT No 2014051

Date/Time: 1 May 2014 1411Z

Position: 5352N 00140W
(1nm S Leeds Bradford airport)

Airspace: Leeds CTR (Class: D)

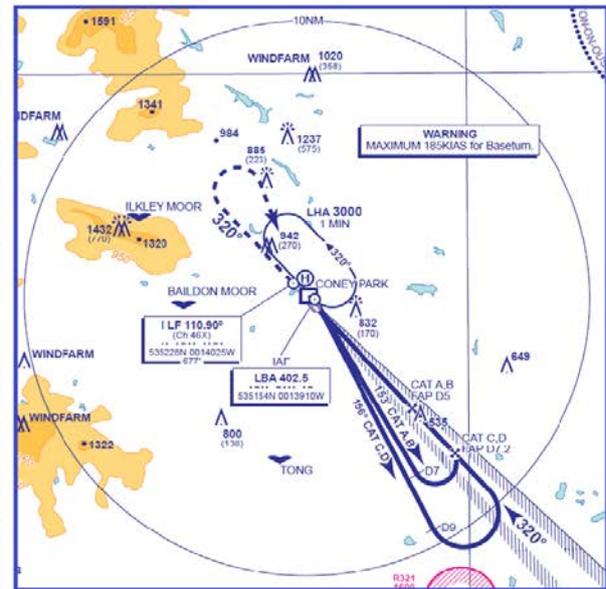
Figure 2 – Leeds Hold & ILS RWY32

LBA was operating on RW32 in fog conditions with Low Visibility Procedures (LVP)/CAT 3 safeguarding operations and a mixture of CAT1 and CAT3 equipped aircraft. The Radar controller normally monitors the Tower frequency at low volume to be aware of the position of departing traffic. Optimised IFR Procedures were in operation (introduced 30 May 2013) which divide the LBA airspace into arrival and departure boxes allowing departing aircraft to achieve continuous climb to FL70 and direct transfer to the designated en-route frequency. Inbounds are released at FL80 or above. For RW32 operations, inbound aircraft are provided with descent when south of a line drawn through Pole Hill (POL)–LBA NDB as shown in Figure 1, which is taken from Prestwick Centre (PC) Supplementary Instruction (SI 052/13). Figure 2 is an extract taken from the UK AIP page AD 2-EGNM-8-7 (18 Oct 12).
