## **AIRPROX REPORT No 2014141**

**Date/Time:** 9 Aug 2014 1349Z (Saturday)

**Position:** 5212N 00010E  
(Cambridge)

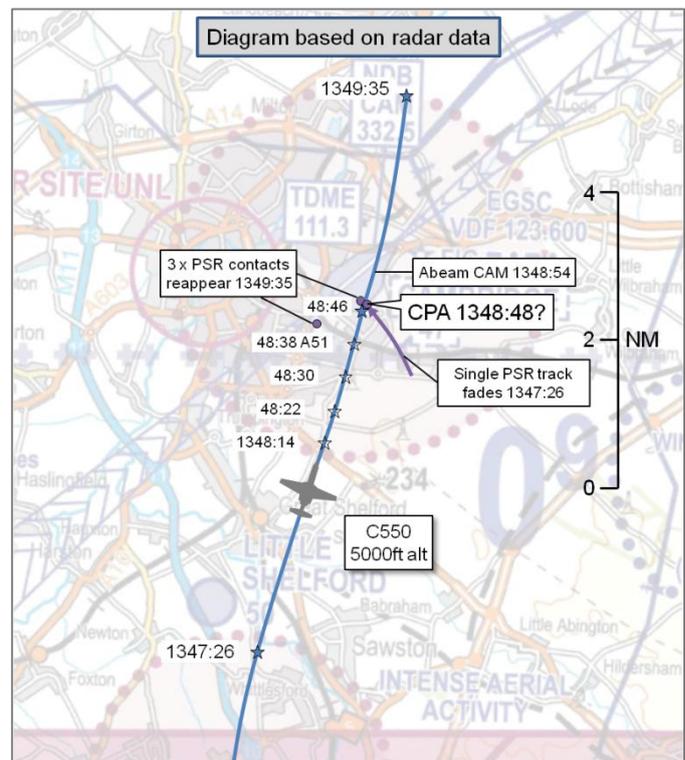
**Reported Separation:**

0ft V/<1nm H

**THE CAMBRIDGE CONTROLLER** reports the C550 was cleared in the decent to the CAM [NDB] initially for an ILS approach RW23. At approximately 1352, and 2nm before reaching the CAM the pilot reported at least three gliders in the CAM overhead all in the altitude block 3500ft to 4500ft. The pilot reported taking avoiding against all three gliders, all within 1nm, one 100ft above and the other two 200ft and 300ft below. The gliders were unknown to Cambridge.
