AIRPROX REPORT No 2014188

Date/Time: 21 Sep 2014 1411Z (Sunday)

Position: 5320N 00242W
(5.3NM E Liverpool Airport
- elevation 81ft)

Airspace: Liverpool CTR (**Class:** D)

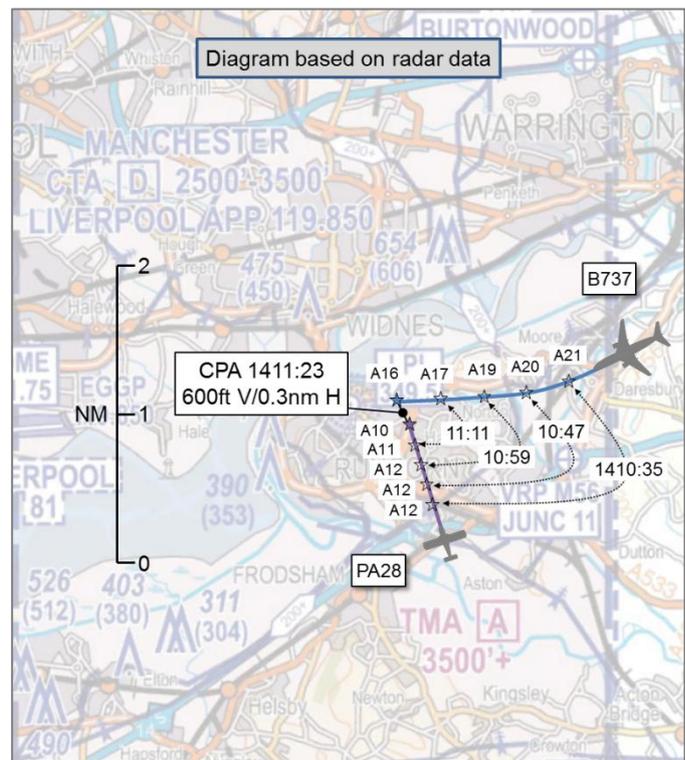
400ft V/>1nm H NK V/2nm H

600ft V/0.3nm H

In considering the risk, the Board noted that both pilots had taken action to avoid a collision, and that at the closest point of approach the two aircraft were separated by 600ft and 0.3nm. Several members considered that the pilots' actions and the minimum vertical distance between the two aircraft indicated that there was no risk of a collision, which meant that the Airprox might be categorised as Risk C. However, a majority of members opined that the situation, within CAS, was not under control. Neither pilot had been issued with timely Traffic Information and both would, quite reasonably, have not been expecting conflicting traffic within CAS that had not been advised. It was considered that it had been fortuitous that the PA28 pilot had sighted the B737 when he did, and that the B737 pilot had been given just enough time to assimilate the Traffic Information and react quickly. Consequently, it was considered that safety margins had been much reduced below the normal and that the Airprox should be categorised as risk Category B.
