AIRPROX REPORT No 2014218

Date/Time: 15 Nov 2014 1338Z (Saturday)

Position: 5154N 00212W
(1.4nm W Gloucester Airport
- elevation 101ft)

Airspace: Gloster ATZ (Class: G)

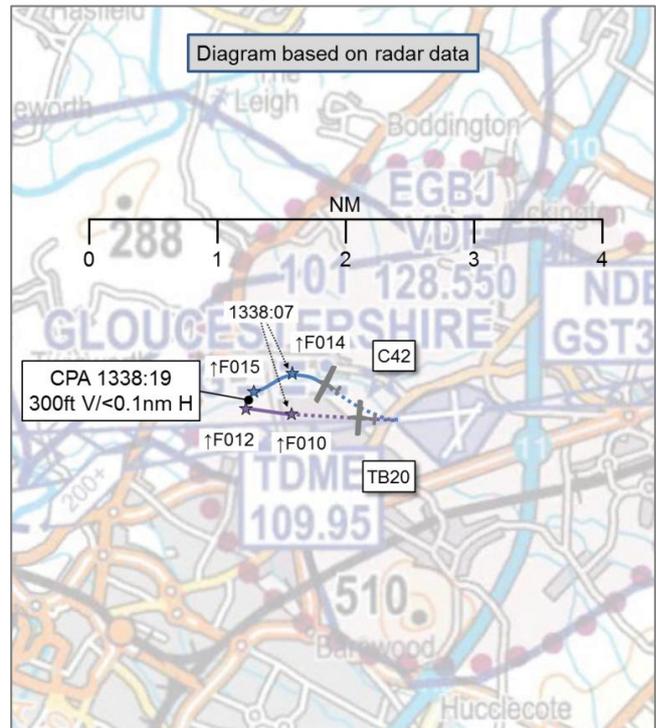
Recorded Separation: 100ft V/0.1nm H

Turning to the pilots, the Board noted that the C42 pilot appeared to have turned some way beyond the noise abatement heading, taking up a track of about 305° rather than the 280° specified in the AIP. Members agreed that this error could easily be explained in terms of it being an instructional sortie with a student at the controls, and of itself was not a cause for concern. The Board also noted that the TB20 pilot had reported visual with the C42 prior to take-off, but had lost sight of it in the climb. He was rightly concerned by his degree of overtake of the C42 and had sensibly turned into an area which he judged to be clear of other traffic. Unfortunately, the seemingly innocuous error in the C42's departure track compounded the TB20's overtake as the C42 pilot turned left, such that the aircrafts' separation decreased markedly. However, members agreed that, fundamentally, it was the TB20 pilot's responsibility to avoid the C42, and that he was aware of such. They also agreed that he had made an effort to ensure such avoidance but, in the end, it was a fact that he had flown into conflict with the C42 having lost sight of it. The Board opined that the TB20 pilot may have been able to mitigate the situation by informing both the C42 pilot and Aerodrome Controller that he had lost sight of the C42. In doing so he would have increased situational awareness and perhaps been able to bring the C42 pilot's and Aerodrome Controller's lookout to bear.

<u>Cause:</u>	The TB20 pilot flew into conflict with the C42, having lost sight of it.
<u>Degree of Risk:</u>	A.
<u>ERC Score³:</u>	20.
