AIRPROX REPORT No 2014219Date/Time: 21 Nov 2014 1252ZPosition: 5400N 00117 W
(Linton-on-Ouse)Airspace: VOY AAIA (Class: G)Aircraft 1 Aircraft 2Type: Tutor TucanoOperator: HQ Air (Trg) HQ Air (Trg)Alt/FL: 1800ft 1900ft
QNH (1016hPa) NK (1019hPa)Conditions: VMC IMCVisibility: 6km 6kmReported Separation:

Recorded Separation: 200ft V/0.4nm H

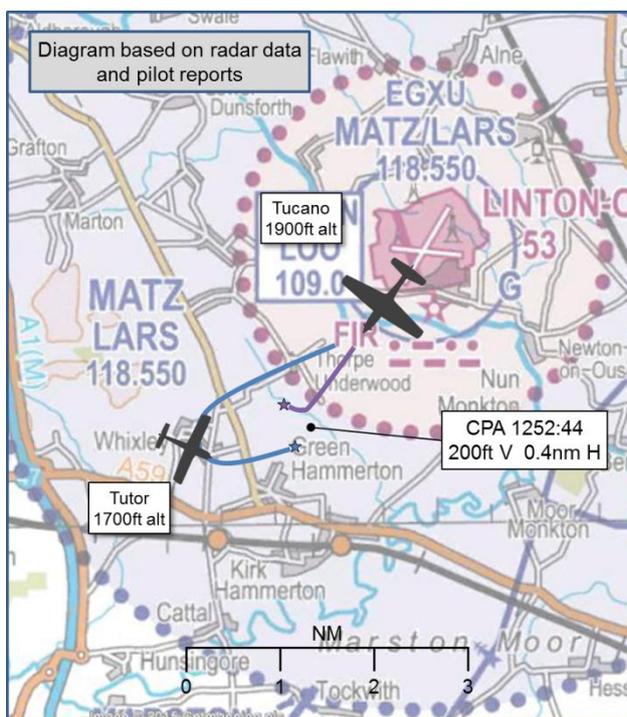
0ft V/500m H 300ft V/1nm H

In identifying the cause, the Board agreed that the Linton procedures had allowed the Tower controller to release the Tucano into conflict with the Tutor. There were also two contributory factors in that the Tutor pilot did not maintain runway track, and the Linton Departures controller's situational awareness had not been brought to bear on the release decision. The risk was the subject of much debate but, in the end, it was agreed that it was Category B; avoiding action was taken, but safety margins had been much reduced below the normal.

Cause: The Linton procedures allowed the Tower Controller to release the Tucano into conflict with the Tutor.

In an attempt to prevent re-occurrence, the unit introduced a procedural change to rectify the issue. The 2-minute time separation has been removed and replaced with procedures to maintain lateral and/or vertical IFR separation.
