AIRPROX REPORT No 2015146

Date: 4 Sep 2015 Time: 1627Z Position: 5331N 00222W Location: Swinton VRP

PART A: SUMMARY OF INFORMATION REPORTED TO UKAB

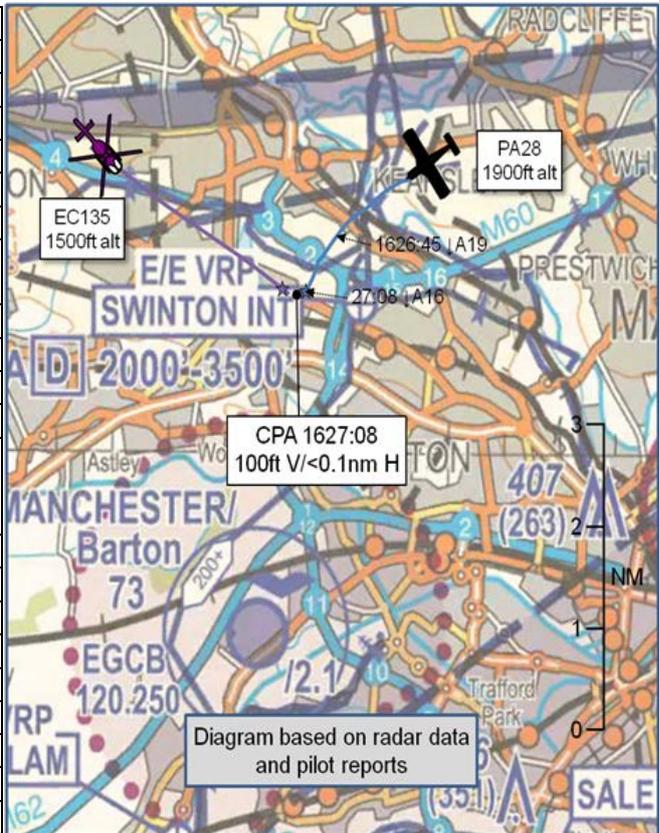
THE EC135 PILOT reports he was routing to a site between Romily and Marple within the Manchester CTR; he had received clearance to enter CAS. After Reebok VRP, he requested local traffic from Barton Information; they passed 2 aircraft in the circuit, one of which was downwind. He was looking for the downwind traffic in the northerly circuit as he was passing 3nm north of Barton. The Air Ambulance radio was particularly busy, so the pilot informed the crew that he was deselecting it and directed the crewman to assist by also monitoring Manchester's frequency. He had just visually acquired the Barton downwind traffic when the crewman, in the co-pilots [left-hand] seat, called traffic slightly high in the 11 o'clock very close and descending. The pilot spotted the traffic, quickly turned left and climbed.

THE PA28 PILOT reports he was at the Swinton Interchange VRP inbound to Barton for a visual recovery, he was in communication with the AFISO at Barton. He did not see the other aircraft.
