**AIRPROX REPORT No 2015187**

Date: 10 Oct 2015 Time: 0947Z Position: 5214N 00252W Location: Shobdon

**PART A: SUMMARY OF INFORMATION REPORTED TO UKAB**

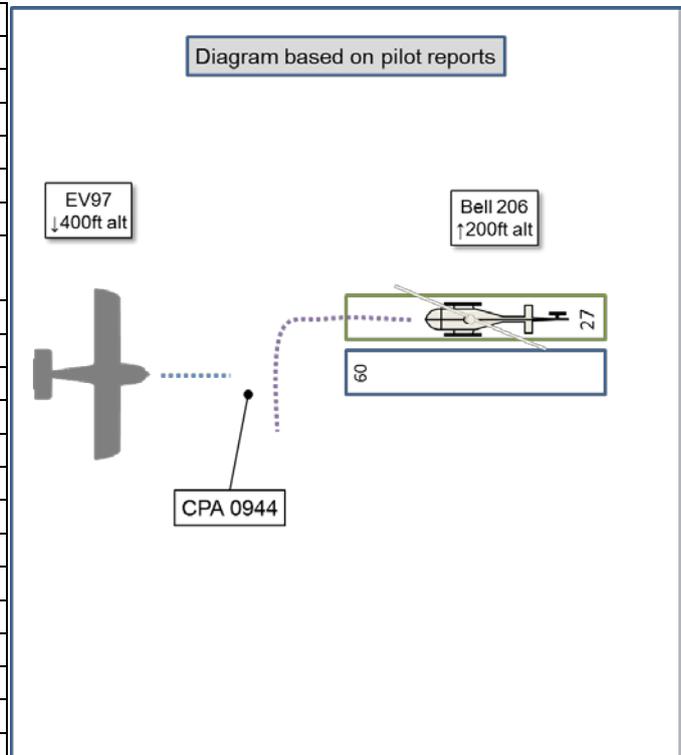
**THE EV97 PILOT** reports that he was conducting a biennial check flight in a privately owned aircraft; the pilot under training was handling the controls and also the radio. After establishing on approach to RW09, but before a final call had been made, the FISO advised that a helicopter was departing from RW27. The student handled the controls whilst the instructor looked for the traffic. Despite the calls from the FISO they were unable to see the traffic until it turned onto a southerly heading. A decision not to go around was made because of the possibility of losing forward visibility due to the altitude change and the unknown position of the helicopter. At the point that they saw the traffic they were 400ft above the ground and the helicopter was about 400m away. The approach was continued without any further deviation.

**THE B206 PILOT** reports that he was given the airfield information and acknowledged that it was RW09 in use, he then departed from RW27 by mistake, realising very shortly after take-off. He commenced a turn towards a southerly heading to follow the noise abatement procedure for RW27, then saw the aircraft on final approach to his right and decided to continue the turn onto south to ensure that there was no conflict.
