AIRPROX REPORT No 2015214

Date: 9 Dec 2015 Time: 1503Z Position: 5417N 00039W Location: Vale of York AIAA

PART A: SUMMARY OF INFORMATION REPORTED TO UKAB

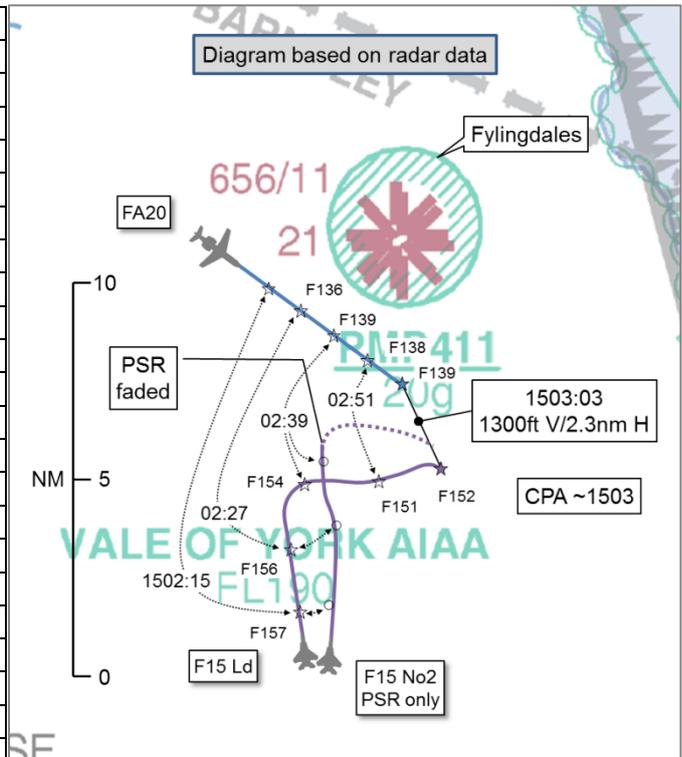
Recorded	Aircraft 1	Aircraft 2
Aircraft	FA20	F15
Operator	Civ Comm	Foreign Mil
Airspace	London FIR	London FIR
Class	G	G
Rules	IFR	VFR
Service	Traffic	Traffic
Provider	Swanwick Mil	Swanwick Mil
Altitude/FL	FL138	FL154
Transponder	A, C, S	A, C, S
Reported		
Colours	Blue, white	Dark grey
Lighting	HISL, nav	Strobes, nav
Conditions	VMC	VMC
Visibility	>10km	>10km
Altitude/FL	FL150	FL150
Altimeter	SPS	SPS
Heading	160°	NK
Speed	300kt	400kt
ACAS/TAS	TCAS II	Not fitted
Alert	RA	N/A
Separation		
Reported	100ft V/0.5nm H	NK
Recorded	NK ¹

THE FA20 PILOT reports levelling at FL150 on instruction from Swanwick Mil, against other traffic. Shortly afterwards, they received a TCAS TA, swiftly followed by an RA. The PF followed the RA until ‘Clear of Conflict’. Two F15s were seen in the right 2 o’clock at about 2nm. They crossed ahead of their aircraft, descending from right to left, before turning right, crossing ahead again and departing to the west. In subsequent UKAB conversation with the FA20 pilot, he noted that he had stated on RT that he would be ‘filing’ but did not think he used the word ‘Airprox’.

THE F15 PILOT reports being in a two-ship of F15s in a descent. Swanwick informed them of the traffic which was picked up on radar at 10nm and visually. The formation continued descent below the traffic, remained visual, and manoeuvred away to the west to avoid further conflict.

¹ The lead F15 was recorded with a minimum separation of 1600ft V/2.4nm H. It was considered that the F15’s formation turn shortly before CPA probably placed the No 2 F15 closer to the FA20. The No2 F15 PSR return faded from area radar during the turn and separation at CPA could not be ascertained from radar.
