AIRPROX REPORT No 2015217

Date: 14 Dec 2015 Time: 1223Z Position: 5056N 00239W Location: Yeovil Westland

PART A: SUMMARY OF INFORMATION REPORTED TO UKAB

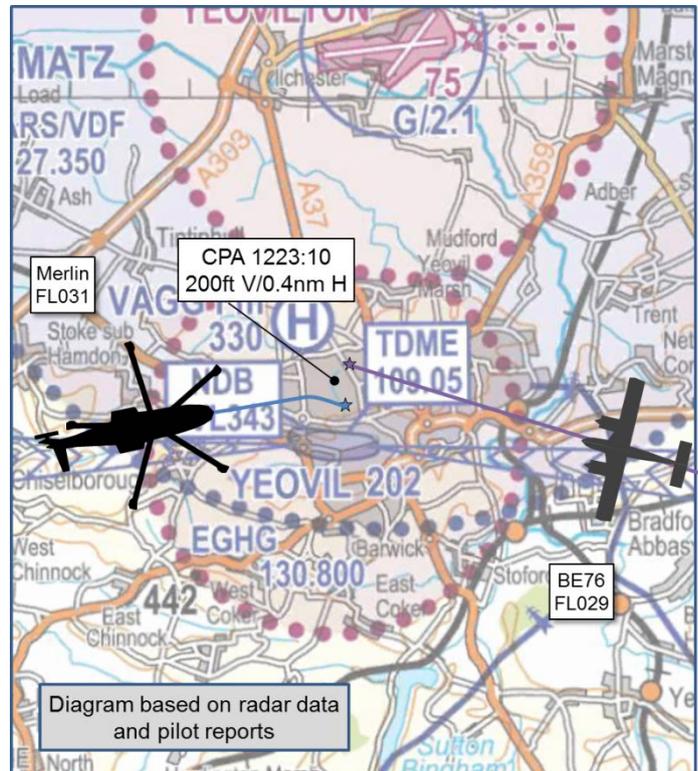
Recorded	Aircraft 1	Aircraft 2
Aircraft	BE76	Merlin
Operator	Civ Trg	RN
Airspace	London FIR	London FIR
Class	G	G
Rules	IFR	IFR
Service	Procedural	Traffic
Provider	Yeovil Westlands App	Yeovilton
Altitude/FL	FL029	FL031
Transponder	A,C,S	A,C
Reported		
Colours	White, red, gold	Dark Green
Lighting	Nav, strobes	Strobes, Nav
Conditions	VMC	VMC
Visibility	>10km	20km
Altitude/FL	3000ft	3000ft
Altimeter	NK	NK
Heading	275°	090°
Speed	120kt	120kt
ACAS/TAS	Not fitted	Not fitted
Separation		
Reported	100ft V/0.25-0.5nm H	1000ft V/1nm H
Recorded	200ft V/0.4nm H

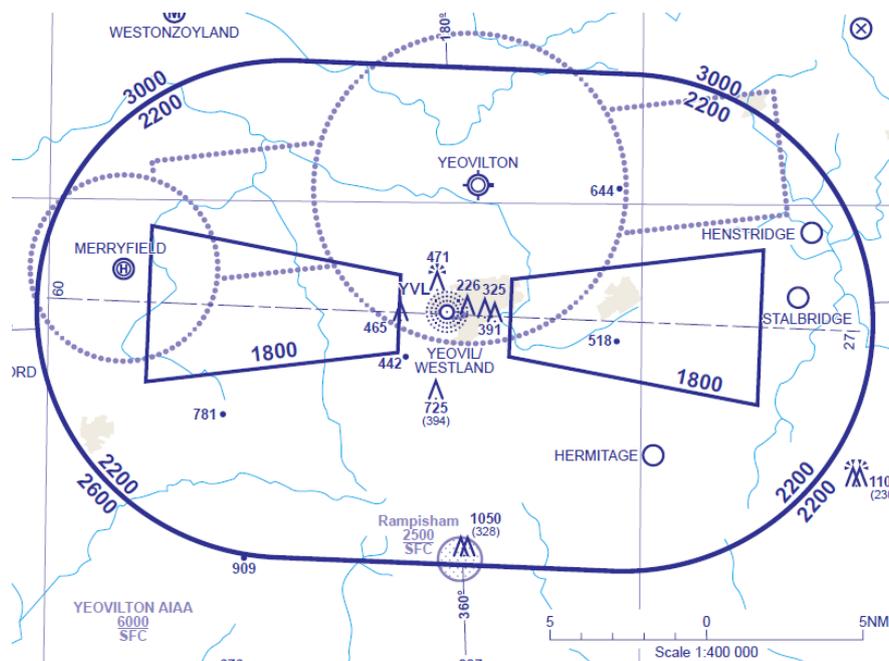
Figure 1 – Extract from the Yeovil Westland ATC Minimum Altitude Chart (UK AIP AD 2-EGHG-5-1)

The relative positions of the YVL NDB and RNAS Yeovilton is shown at figure 1.
