AIRPROX REPORT No 2016044

Date: 01 Apr 2016 Time: 1757Z Position: 5157N 00145E Location: 46nm NE Southend

PART A: SUMMARY OF INFORMATION REPORTED TO UKAB

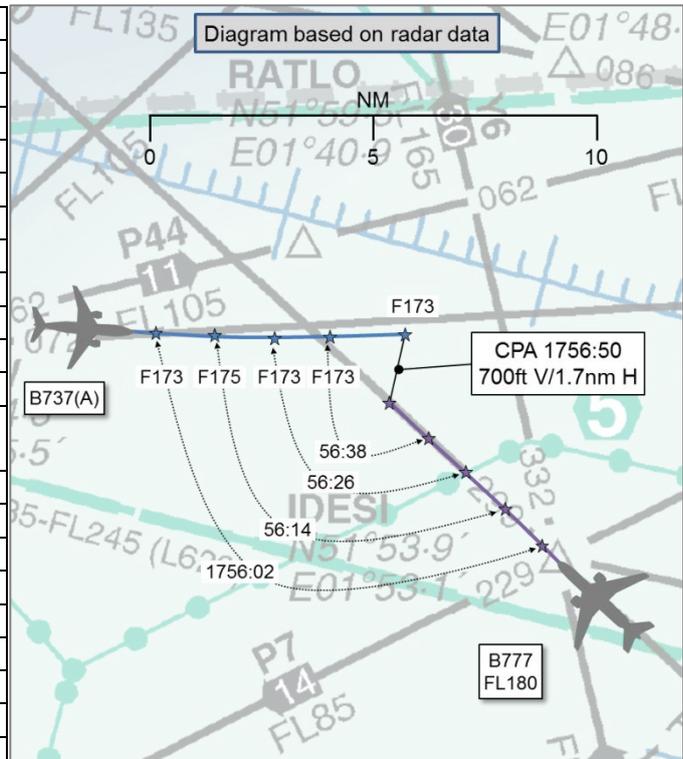
Recorded	Aircraft 1	Aircraft 2
Aircraft	B737(A)	B777
Operator	CAT	Civ Comm
Airspace	London TMA	London TMA
Class	A	A
Rules	IFR	IFR
Service	Radar Control	Radar Control
Provider	Swanwick	Swanwick
Altitude/FL	FL173	FL180
Transponder	A, C, S	A, C, S
Reported		
Colours	Company	NK
Lighting	Strobes, nav, anti-collision	NK
Conditions	VMC	NK
Visibility	10km	NK
Altitude/FL	FL173	NK
Heading	072°	NK
Speed	280kt	NK
ACAS/TAS	TCAS II	Unknown
Alert	TA	Unknown
Separation		
Reported	700ft V/5nm H	NK
Recorded	700ft V/1.7nm H
