AIRPROX REPORT No 2016102

Date: 10 Jun 2016 Time: 1604Z Position: 5058N 00219W Location: 1nm SW Henstridge

PART A: SUMMARY OF INFORMATION REPORTED TO UKAB

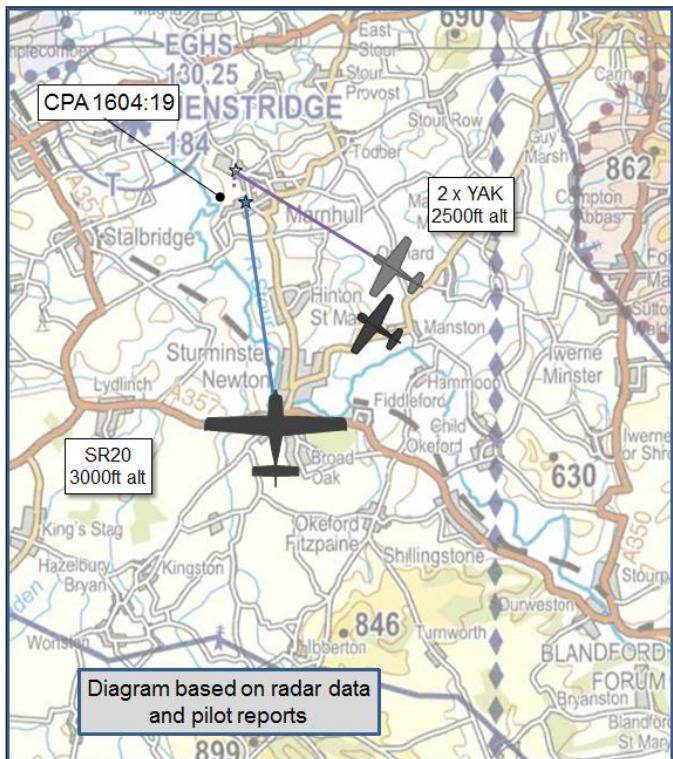
Recorded	Aircraft 1	Aircraft 2
Aircraft	YAK 50	Cirrus SR20
Operator	Civ Pte	Civ Pte
Airspace	Lon FIR	Lon FIR
Class	G	G
Rules	VFR	VFR
Service	None	Traffic
Provider		Bournemouth
Altitude/FL	2500ft	2600ft
Transponder	On Standby	A, C, S
Reported		
Colours	Silver, Red	White
Lighting	Nil	Strobes, Nav
Conditions	VMC	VMC
Visibility	>10km	>10km
Altitude/FL	1700ft	3000ft
Altimeter	QNH (1004hPa)	NK (1008hPa)
Heading	180°	350°
Speed	130kt	140kt
ACAS/TAS	Not fitted	TAS
Alert	N/A	TA
Separation		
Reported	0ft V/30m H	N/K
Recorded	100ft V/0.4nm H (YAK 1)
