**AIRPROX REPORT No 2016130**

Date: 05 Jul 2016 Time: 1438Z Position: 5117N 00020W Location: 8.7nm NNW Gatwick airport

**PART A: SUMMARY OF INFORMATION REPORTED TO UKAB**

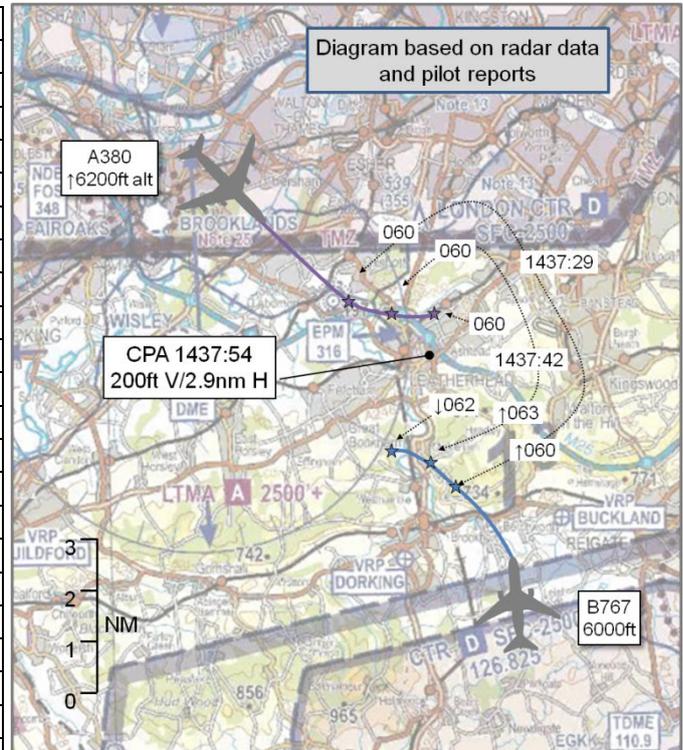
Recorded	Aircraft 1	Aircraft 2
Aircraft	B767	A380
Operator	CAT	CAT
Airspace	London TMA	London TMA
Class	A	A
Rules	IFR	IFR
Service	Radar Control	Radar Control
Provider	Swanwick TC	Swanwick TC
Altitude/FL	6200ft	6000ft
Transponder	A,C,S	A,C,S
Reported		
Colours	Company	Company
Lighting	NK	NK
Conditions	VMC	IMC
Visibility	NK	
Altitude/FL	4000ft	
Altimeter	QNH	
Heading	078°	
Speed	220kt	
ACAS/TAS	TCAS II	TCAS II
Alert	None	TA
Separation		
Reported	NK	NK
Recorded	200ft V/2.9nm H
