AIRPROX REPORT No 2016171

Date: 17 Aug 2016 Time: 0950Z Position: 5744N 00318W Location: Lossiemouth

PART A: SUMMARY OF INFORMATION REPORTED TO UKAB

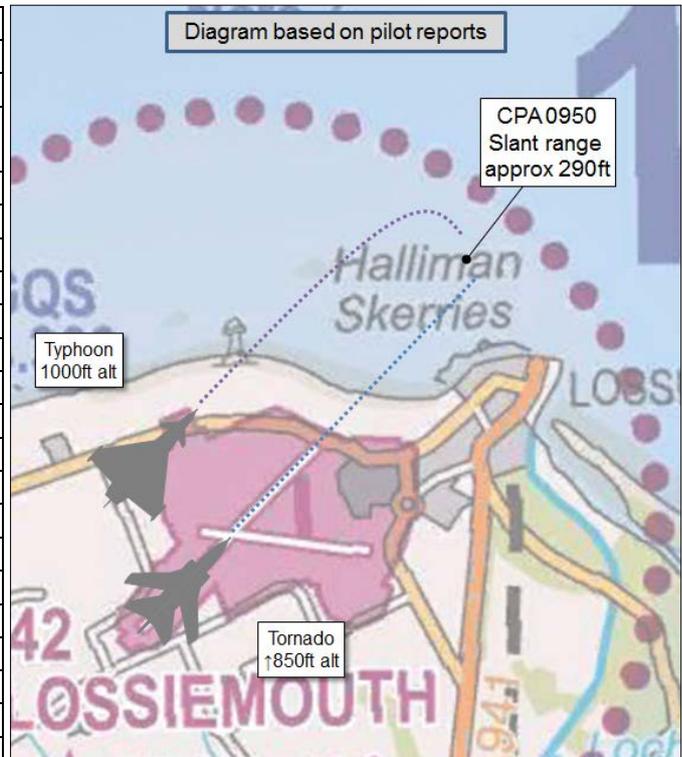
THE TORNADO PILOT reports that he was No4 in a formation of 4 Tornados. They were departing on SID05A in a stream of 2 pairs with 2 min separation between the pairs and 30 secs between each aircraft within the pair. The first pair departed and the second pair were given clearance to line-up and wait. At the same time he was aware that a formation of Typhoons were calling for a visual join. Take-off clearance was given, and the No3 aircraft rolled at 0949:20. At 0949:34 the Typhoon formation called initials, and at 0949:50 he commenced his take-off run. As he got airborne, the joining Typhoon formation lead called 'on the break' followed by the intentions of the other elements. At 0950:40 his Tornado pair switched frequency from tower to departures. At 0950:44 he was aware of a flash in his left 8 o'clock and he turned his head to see a Typhoon which was either canopy, or belly towards him and obviously reversing its turn away from him. At this point he was at 840ft and he stopped his climb to try and comprehend what was going on; the Typhoon stabilised into a fighting wing position¹ behind him before breaking behind into the circuit. After his pair checked in on the Departures frequency, he reported that a Typhoon had come close to him and was told that it was circuit traffic. There were no TCAS indications throughout, and even after the event he could not see the contact on TCAS.

THE TYPHOON PILOT reports that he was recovering to Lossiemouth as the No4 in a formation of Typhoons. Upon initiating a gentle break in the 05RH circuit to route around Lossiemouth village (for noise abatement), he became aware of a Tornado climbing out and in close proximity on the inside of

his turn. Assessment at the time was a separation of 300ft, with the Tornado behind and below. He immediately reversed the turn and climbed, rolling out to establish positive separation and then climbed to break into the circuit over the Tornado, whilst remaining visual. A more detailed description with timings taken from Rangeless Airborne Information Distribution System (RAIDS) follows: The formation had changed to Lossiemouth Tower at 11,000ft and were passing 10,000ft when the second Tornado pair were told to line-up and wait. The Typhoon formation was at 5000ft, 8nm from Lossiemouth, very wide downwind and positioning for initial when the Tornados were given clearance to take-off. At this point, although aware of the departing traffic, he believed that they would be well clear by the time the Typhoons reached the circuit. When the formation lead called initials, ATC responded with 'Roger', which backed up his assumption that the departing traffic was clear. Additionally an earlier flight of Tornados that they were unaware of were airborne and showing on the MIDS PPLIs [datalink system], clear of the circuit. His aircraft radar was in PASSIVE mode due to the proximity of the other members of the formation. There was limited opportunity for him to look for the Tornados due to being No4 of the formation in echelon for the run and break. The first 3 Typhoons broke starting from the runway threshold, but the No4 maintained straight-and-level at 300kts, slowly decelerating to 290kts over the deadside at 1000ft to avoid overflying Lossiemouth village. He cleared his flightpath right 2 to 3 o'clock before turning, but did not look back 4 to 5 o'clock (where the Tornado now was) until initiating the roll. The Tornados called switching frequency, a few seconds later he initiated the roll to the right (slant range on RAIDS was 500ft); 2 seconds later he reversed the turn and climbed (slant range was 410ft); 3 seconds later the pilot rolled out and checked separation (slant range 345ft). CPA occurred once the Typhoon pilot was visual and separating laterally and had started the climb with slant range at 290ft.
