AIRPROX REPORT No 2016173

Date: 16 Aug 2016 Time: 1521Z Position: 5038N 00131W Location: SW Newport, Isle of Wight

PART A: SUMMARY OF INFORMATION REPORTED TO UKAB

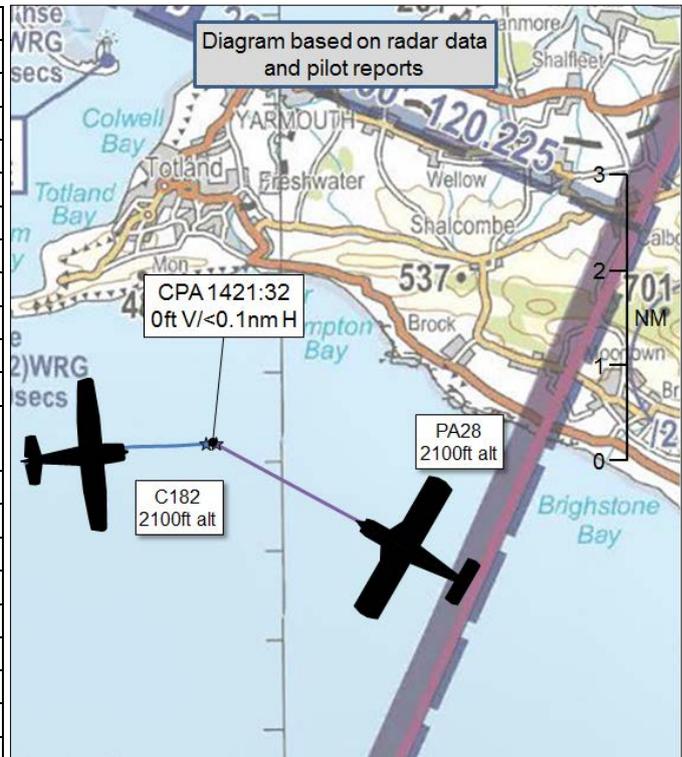
| Recorded | Aircraft 1 | Aircraft 2 |
|---|---|---|
| Recorded | 0ft V/<0.1nm H | |

THE C182 PILOT reports that he was on the final phases of a flight to his destination. He was flying VFR over the Isle of Wight at around 2000ft. Having just left the Bournemouth Radar frequency, and while attempting to change to Solent Radar, he suddenly noticed the opposite direction traffic in about the 1 o'clock position and slightly high. He immediately took avoiding action with a right turn and descent. This action was partially delayed because the autopilot was on and the override was compensated for by the trim running. The autopilot was switched off, and the turn and descent continued. The opposite-direction traffic passed by also turning right and appearing to climb. There was not sufficient time to identify the other aircraft. On reflection two learning points were observed. When returning to a busy flying area such as the Isle of Wight, extra care should be taken to scan for and avoid other traffic. Secondly, beware of distractions from changing frequencies and be double sure of the autopilot cancel button on the aircraft yolk.

The Board then considered the cause and risk of the incident. They agreed that both pilots had been distracted by in-cockpit tasks which had degraded their lookout to the point that this incident was caused by a late sighting by both pilots. Turning to the risk, the Board agreed that this was an incident where safety had been much reduced below the norm; they therefore assessed the risk as Category B.

Cause: A late sighting by both pilots.
