AIRPROX REPORT No 2016181

Date: 24 Aug 2016 Time: 1435Z Position: 5324N 00034W Location: N of Scampton

PART A: SUMMARY OF INFORMATION REPORTED TO UKAB

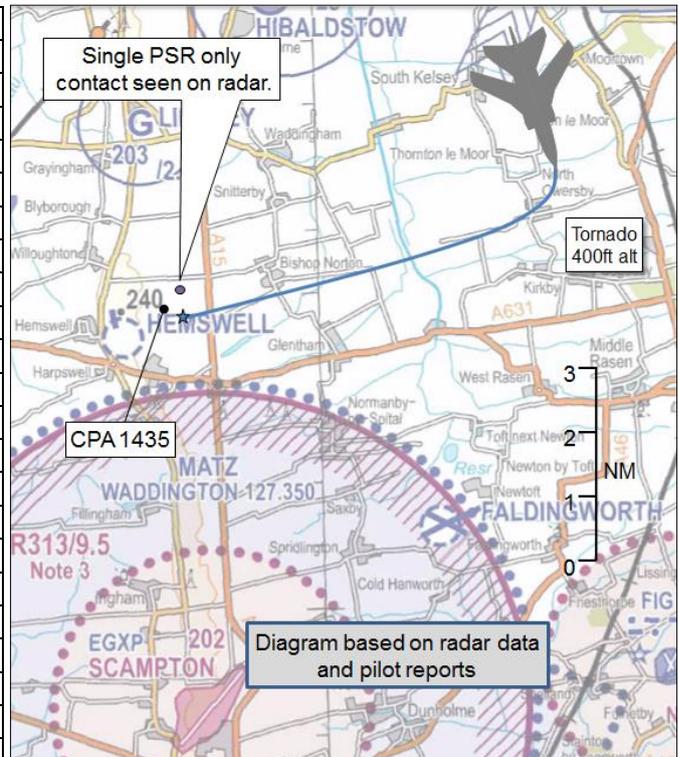
THE TORNADO PILOT reports that he was conducting a low-flying portion of a sortie, which had been planned, input into CADS and low-level bookings made. Whilst flying west through the Scampton/Kirton-in-Lindsey gap, the pilot saw a light aircraft, believed to be a glider, flying in the opposite direction. It appeared to be co-altitude, approximately 70-100m offset, and banking away. When spotted, it was already in the 2:30 position and too late to take any avoiding action. The crew were listening out on the low-level common frequency at the time, although were in the process of trying to raise Waddington ATC to ask for an ATS from them.

He assessed the risk of collision as ‘Low’.
