AIRPROX REPORT No 2016196

Date: 01 Sep 2016 Time: 1329Z Position: 5109N 00036E Location: Lashenden/Headcorn Airfield

PART A: SUMMARY OF INFORMATION REPORTED TO UKAB

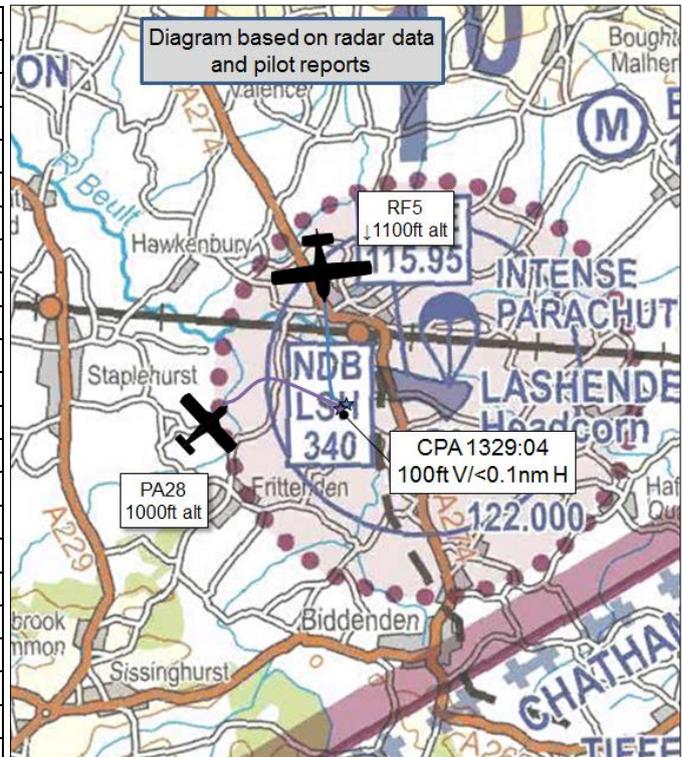
Recorded	Aircraft 1	Aircraft 2
Aircraft	RF5	PA28
Operator	Civ Pte	Civ Trg
Airspace	Headcorn ATZ	Headcorn ATZ
Class	G	G
Rules	VFR	VFR
Service	AGCS	AGCS
Provider	Headcorn	Headcorn
Altitude/FL	1100ft	1000ft
Transponder	On/S	On/C
Reported		
Colours	White, Red	White, Blue
Lighting	Anti Col	Beacon, Strobe
Conditions	VMC	VMC
Visibility	>10km	15km
Altitude/FL	1000ft	1000ft
Altimeter	QFE	QNH (1023hPa)
Heading	107°	100°
Speed	70kt	90kt
ACAS/TAS	Not fitted	Not fitted
Alert	N/A	N/A
Separation		
Reported	50ft V/20m H	100ft V/40m H
Recorded	100ft V/<0.1nm H
