AIRPROX REPORT No 2016260

Date: 08 Dec 2016 Time: 1628Z (Twilight) Position: 5114N 00049W Location: 3nm SW Farnborough

PART A: SUMMARY OF INFORMATION REPORTED TO UKAB

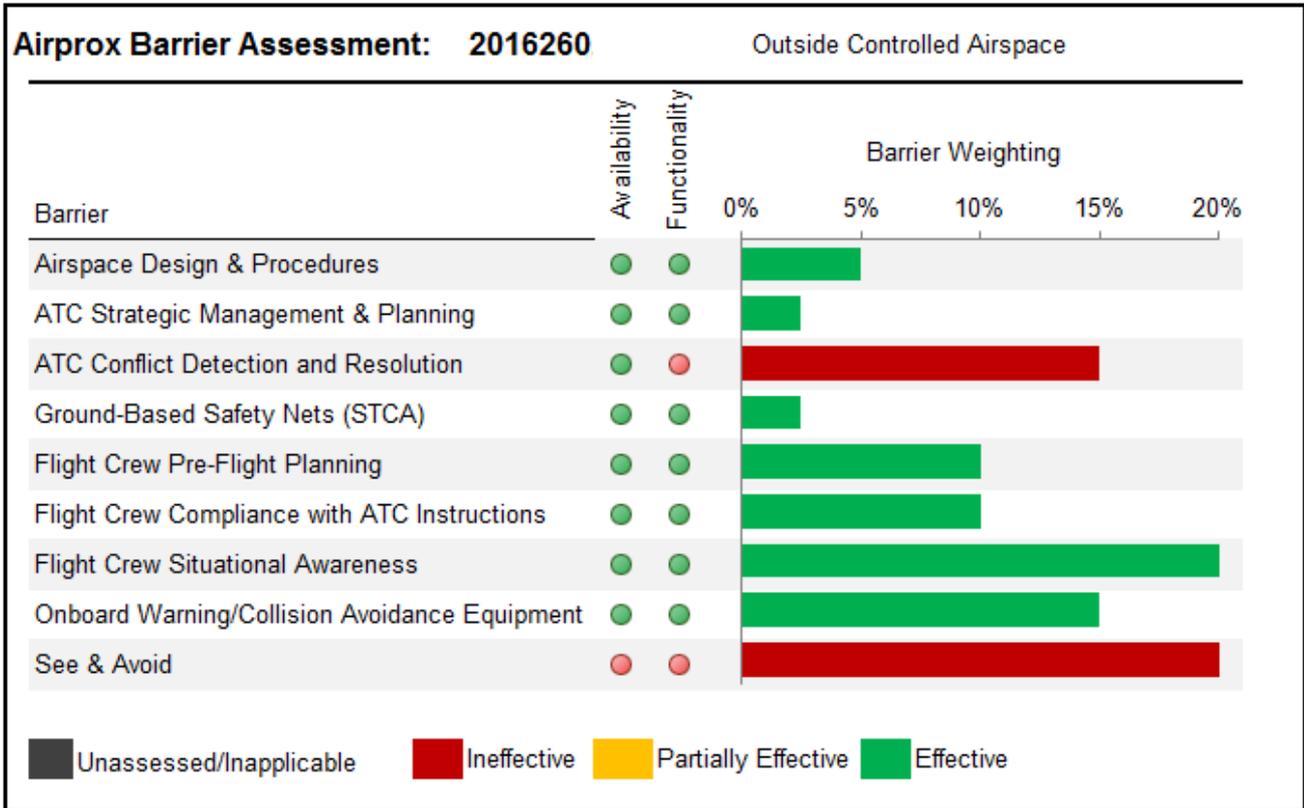
See and Avoid was **not available** and thereby **ineffective** because the aircraft were in cloud.

⁸ Modern safety management processes employ the concept of safety barriers that prevent contributory factors or human errors from developing into accidents. Based on work by EASA, CAA, MAA and UKAB, the table depicts the barriers associated with preventing mid-air-collisions. The length of each bar represents the barrier's weighting or importance (out of a total of 100%) for the type of airspace in which the Airprox occurred (i.e. Controlled Airspace or Uncontrolled Airspace). The colour of each bar represents the Board's assessment of the effectiveness of the associated barrier in this incident (either Fully Effective, Partially Effective, Ineffective, or Unassessable/Inapplicable). The chart thus illustrates which barriers were effective and how important they were in contributing to collision avoidance in this incident. The UK Airprox Board scheme for assessing the Availability, Functionality and Effectiveness of safety barriers can be found on the [UKAB Website](#).
