AIRPROX REPORT No 2017042

Date: 25 Mar 2017 Time: 1420Z Position: 5620N 00331W Location: 8nm SW Perth

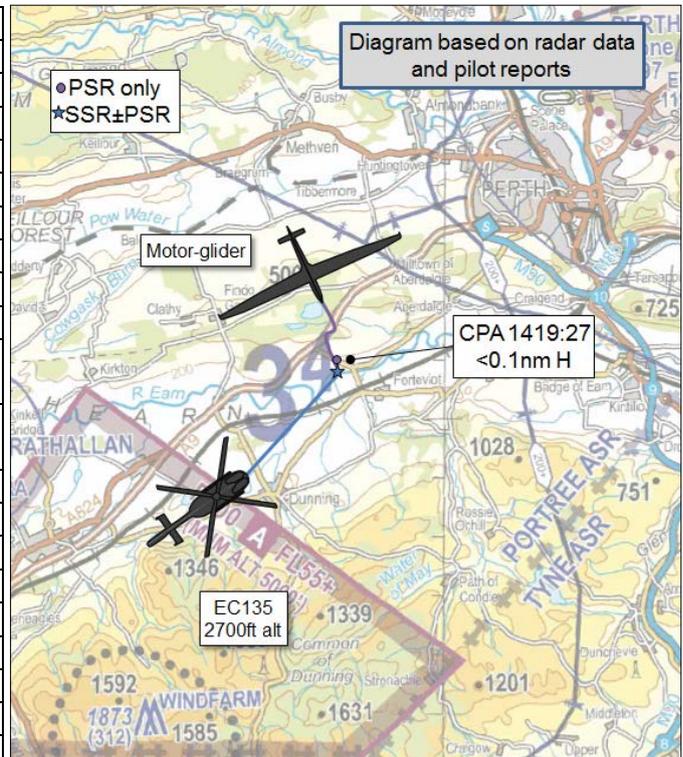
THE EC135 PILOT reports that he was returning to his base having dropped off a patient in Glasgow. He was in the open FIR, 8nm SW Perth, and had just left Scottish Info’s frequency, but not yet checked in on Perth’s. He was in a gentle descent from 3500ft to 1400ft. They were running through the arrival check-list when a mid-wing, red and white motor-glider, thought to be a Schiebe-Falke SF25, appeared from behind the windscreen pillar, slightly below the 10-11 o’clock position, head-on and on a converging course. He manoeuvred to the right and he saw the motor-glider also turn away and pass down the left-hand side, 200m laterally and 25ft vertically. The motor-glider had been invisible to the RHS pilot due to being obscured by the windscreen pillar, and the LHS paramedic was heads-in reading the checklist at the time.

He assessed the risk of collision as ‘High’.
