**AIRPROX REPORT No 2017078**

Date: 27 Apr 2017 Time: 0908Z Position: 5043N 00250W Location: Lyme Bay North

**PART A: SUMMARY OF INFORMATION REPORTED TO UKAB**

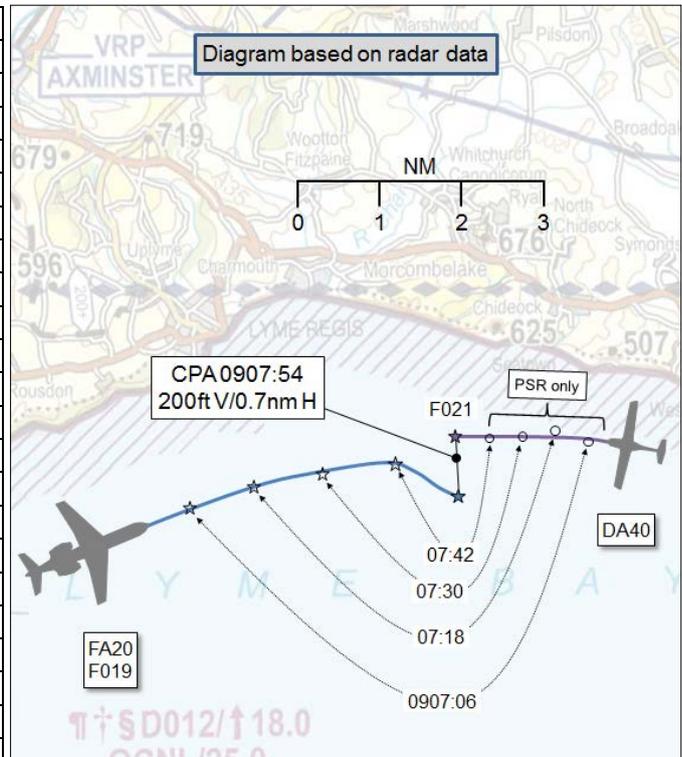
Recorded	Aircraft 1	Aircraft 2
Aircraft	FA20	DA40
Operator	Civ Comm	Civ Trg
Airspace	EG D012	EG D012
Class	Danger Area	Danger Area
Rules	VFR	VFR
Service	Traffic	None
Provider	Plymouth Mil	(Exeter)
Altitude/FL	FL019	FL021
Transponder	A, C, S	A, C, S
Reported		
Colours	NK	White, blue
Lighting	NK	NK
Conditions	VMC	VMC
Visibility	10km	>10km
Altitude/FL	2000ft	2300ft
Altimeter	RPS (NK hPa)	QNH (NK hPa)
Heading	090°	280°
Speed	230kt	120kt
ACAS/TAS	TCAS II	Not fitted
Alert	RA	N/A
Separation		
Reported	300ft V/2nm H	Not seen
Recorded	200ft V/0.7nm H
