AIRPROX REPORT No 2017087

Date: 10 May 2017 Time: 1359Z Position: 5421N 00133W Location: Catterick

PART A: SUMMARY OF INFORMATION REPORTED TO UKAB

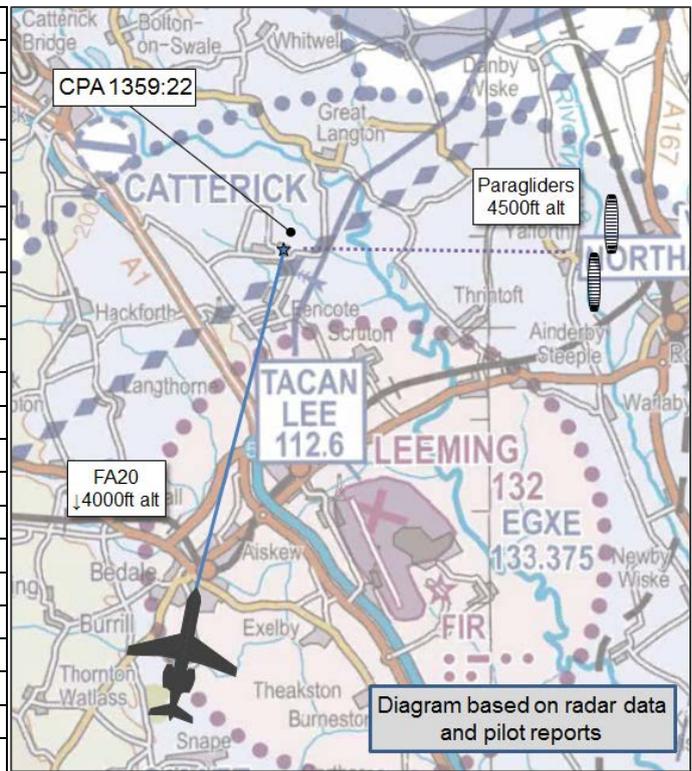
Recorded	Aircraft 1	Aircraft 2
Aircraft	FA20	Paraglider
Operator	Civ Comm	Civ Pte
Airspace	London FIR	London FIR
Class	G	G
Rules	VFR	VFR
Service	Traffic	None
Provider	Durham Tees	
Altitude/FL	FL049	
Transponder	A, C, S	Not fitted
Reported		
Colours	Blue, White	
Lighting	HISLs, Nav	Nil
Conditions	VMC	VMC
Visibility	20km	40km
Altitude/FL	4000ft	4500ft
Altimeter	QNH (1005hPa)	1013 hPa
Heading	020°	090°
Speed	240kt	25kt
ACAS/TAS	TCAS II	Not fitted
Alert	None	N/A
Separation		
Reported	0ft V/100m H	0ft V/500m H
Recorded	NK

THE FA20 PILOT reports that he was in a visual descent into Durham Tees Valley airfield from the SW, for a VFR join to RW23. He was passing through 4000ft and the cloud was SCT/BKN layer between 4500-5500ft. He was receiving a Traffic Service from ATC and had been given Traffic Information on traffic recovering to Leeming and on arriving and departing traffic from Durham. He was adjusting his track to deconflict with departing fast-jet traffic when he passed very close to 3 paragliders (he thought), estimated to be 300ft laterally. The paragliders appeared to be in a formation, heading south to south-west at 4000ft. There was no time to take avoiding action, other than to maintain his safe vector past the paragliders; he did not believe that the wake of the aircraft affected the paragliders. The ATC frequency was busy and the controller had not called the paragliders to him. He did not report the Airprox at that point but, after landing, called ATC to advise them of the incident.
