**AIRPROX REPORT No 2017091**

Date: 14 May 2017 Time: 1140Z Position: 5315N 00051W Location: Darlton Glider Site

**PART A: SUMMARY OF INFORMATION REPORTED TO UKAB**

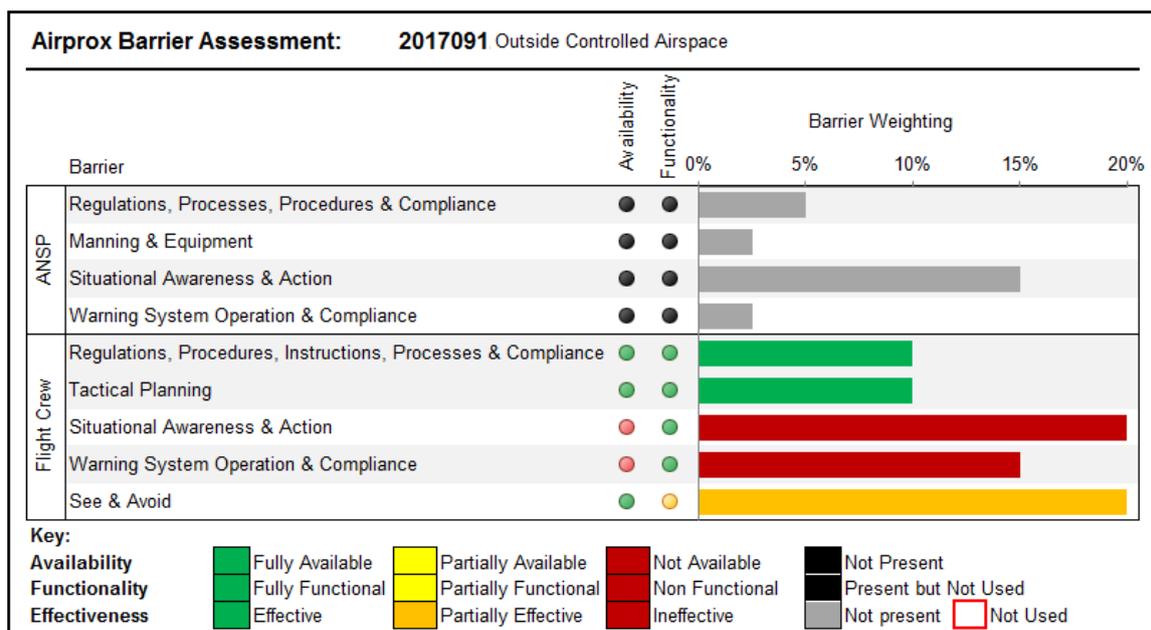
Safety Barrier Assessment<sup>3</sup>

**Flight Crew Situational Awareness and Action** was considered to be **ineffective** because neither aircraft was aware of the other until just before CPA.

**Flight Crew Warning System Operation and Compliance** was also considered to be **ineffective** because the ASW15 had FLARM but the microlight appeared not to be transponder or FLARM equipped, which negated the FLARM capability.

**See and Avoid** was considered to be **partially effective** because the ASW15 pilot saw the microlight late but with time to initially carry out an avoiding action manoeuvre and then reassess and determine this was not required. The microlight pilot probably did not see the ASW15.
