**AIRPROX REPORT No 2017099**

Date: 25 May 2017 Time: 1221Z Position: 5203N 00053W Location: 3nm W Milton Keynes

**PART A: SUMMARY OF INFORMATION REPORTED TO UKAB**

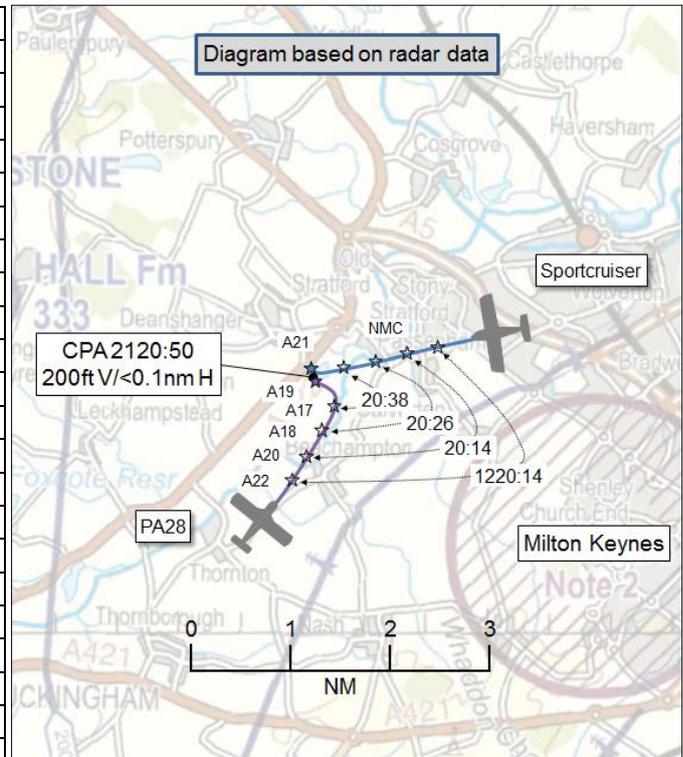
Recorded	Aircraft 1	Aircraft 2
Aircraft	Sportcruiser	PA28
Operator	Civ Club	Civ Trg
Airspace	London FIR	London FIR
Class	G	G
Rules	VFR	VFR
Service	Basic	Basic
Provider	Oxford	Cranfield
Altitude/FL	2100ft	1900ft
Transponder	A, C	A, C
Reported		
Colours	White, blue, gold	White, gold
Lighting	Strobes, nav	NK
Conditions	VMC	VMC
Visibility	>50km	10km
Altitude/FL	1892ft	2500ft
Altimeter	QNH (1023hPa)	QNH (NK hPa)
Heading	256°	NK
Speed	96kt	100kt
ACAS/TAS	Not fitted	Not fitted
Separation		
Reported	100ft V/300m H	500ft V/0.5nm H
Recorded	200ft V/<0.1nm H

**THE SPORTCRUISER PILOT** reports the PF had just completed a radio call to Oxford Radar when 'P2' saw a white and magenta, low-wing, PA28-type aircraft closing from the 8 o'clock at a similar height and estimated distance of 300m. The 'P2' immediately called 'I have control' and executed a 360° right-hand turn whilst the former PF maintained visual contact with the other aircraft. Once back on track, and with the other aircraft to their northwest, they resumed their course. The other aircraft then turned through 180° and passed back over them with more vertical and horizontal separation. 'P2' called Oxford Radar to inform them that a plane had passed close by, from left to right. Oxford Radar told them that there was a lot of traffic squawking 4520 and offered to identify them, which they accepted. They were identified and then informed that an aircraft was leaving their vicinity to the south, which they presumed to be the aircraft they had just seen. They were asked if they wanted to continue with a Basic Service or to receive a Traffic Service and they elected to remain with a Basic Service as they were shortly to switch to their destination aerodrome's frequency. The pilot noted that the other aircraft's pilot not appear to see them because the aircraft did not vary its flight-path and did not give way to them.

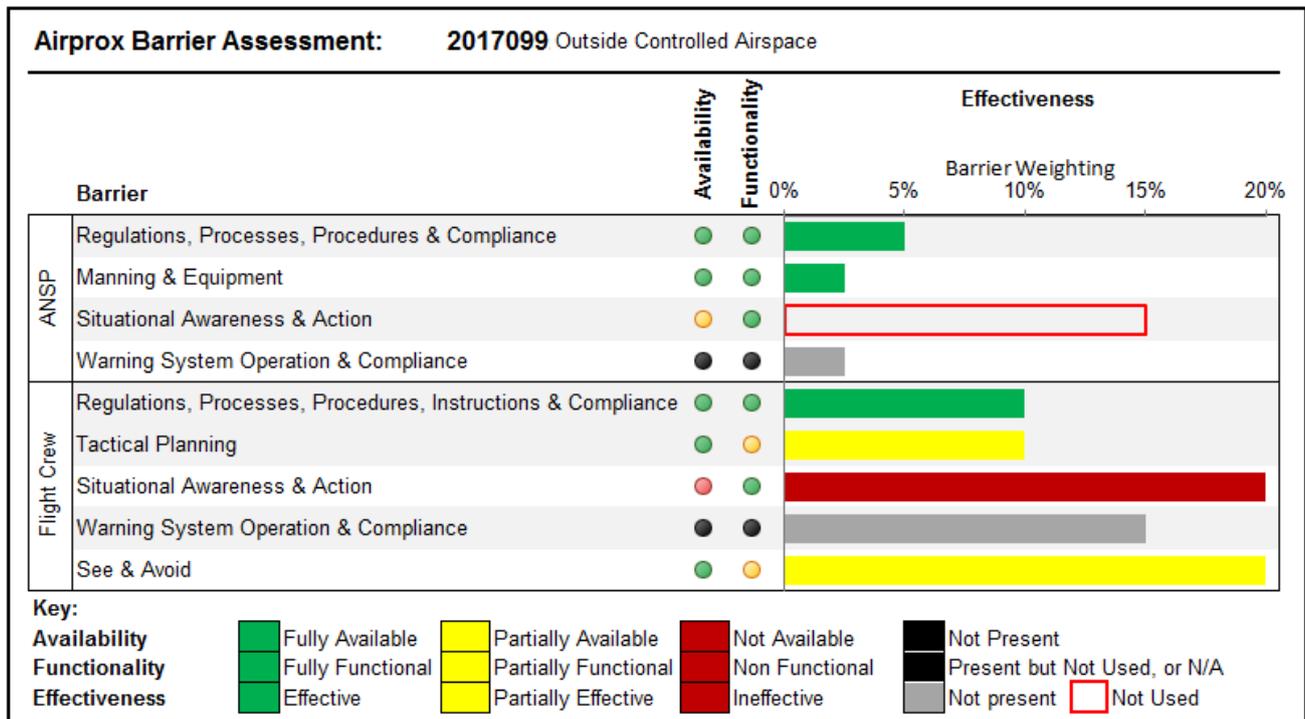
**Situational Awareness and Action** were assessed as **ineffective** because neither was in possession of sufficient Situational Awareness to affect the outcome.

**See and Avoid** were assessed as **partially effective** because both pilots saw the other aircraft at a late stage.
