AIRPROX REPORT No 2017127

Date: 25 Jun 2017 Time: 1637Z Position: 5200N 00209W Location: Tewkesbury

PART A: SUMMARY OF INFORMATION REPORTED TO UKAB

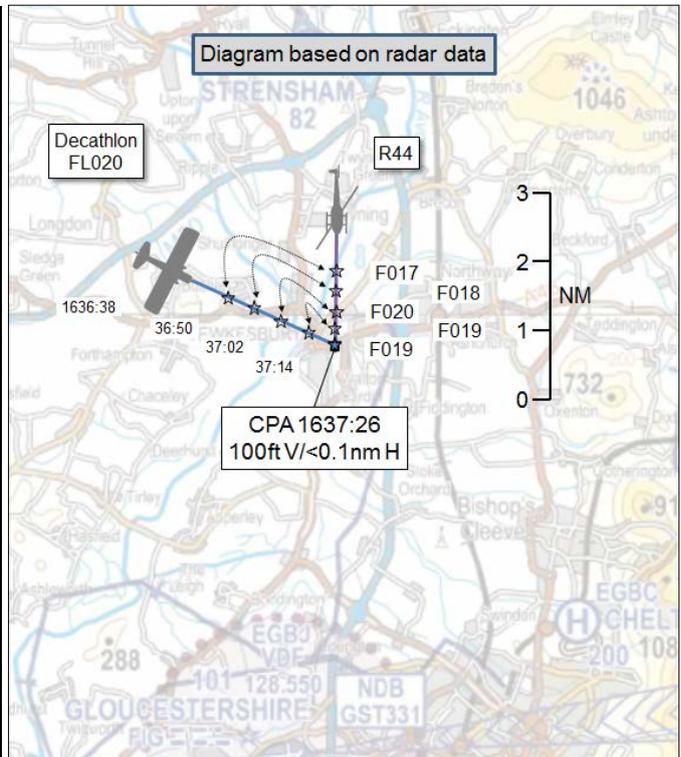
THE DECATHLON PILOT reports being in the cruise a quarter of a mile southeast of Tewkesbury, listening out on the Gloucester frequency, when ‘something caused her to look over her left shoulder’. She glimpsed a red Robinson helicopter just before it passed behind. She then looked over her right shoulder as it flew away, apparently straight-and-level. She noted it was an R44 with a gold logo, flying in the general direction of Gloucester. She reported the Airprox to the Gloucester controller. The pilot noted that the occurrence may have been mitigated if she had contacted Gloucester sooner but that a Basic Service was of limited value, as the controller agency was not obligated to provide Traffic Information. The pilot also noted that visual identification of aircraft on a constant relative bearing was difficult for the human eye and stated that electronic conspicuity together with aids to visual identification in the form of ADS-B and an audible warning to prompt pilots to lookout in a particular direction would be of significant benefit in UK airspace, which has very limited assistance available for GA pilots.

THE R44 PILOT reports conducting an instructional sortie, in straight-and-level flight having asked the handling pilot (HP) to call Gloucester to rejoin as they got to Tewkesbury. As she turned to the right to speak to the HP, she saw a high-wing, single-engine, fixed-gear aircraft, slightly behind and less than a mile in range, and therefore lowered the collective lever sharply to reduce their height. The HP did not see the aircraft, which passed ahead and above.

The Board quickly agreed that the occurrence had been caused by the late sighting of the Decathlon by the R44 pilot and, with the R44 passing behind at first sighting, the effective non-sighting by the Decathlon pilot. Some members felt that the separation was such that collision had only been avoided by providence, but the majority were of the opinion that the R44 pilot's late sighting had afforded sufficient warning to take effective avoiding action, albeit with safety much reduced.

Cause: A late sighting by the R44 pilot and effectively a non-sighting by the Decathlon pilot.
