**AIRPROX REPORT No 2017142**

Date: 05 Jul 2017 Time: 1233Z Position: 5305N 00402W Location: Llanberis Pass

**PART A: SUMMARY OF INFORMATION REPORTED TO UKAB**

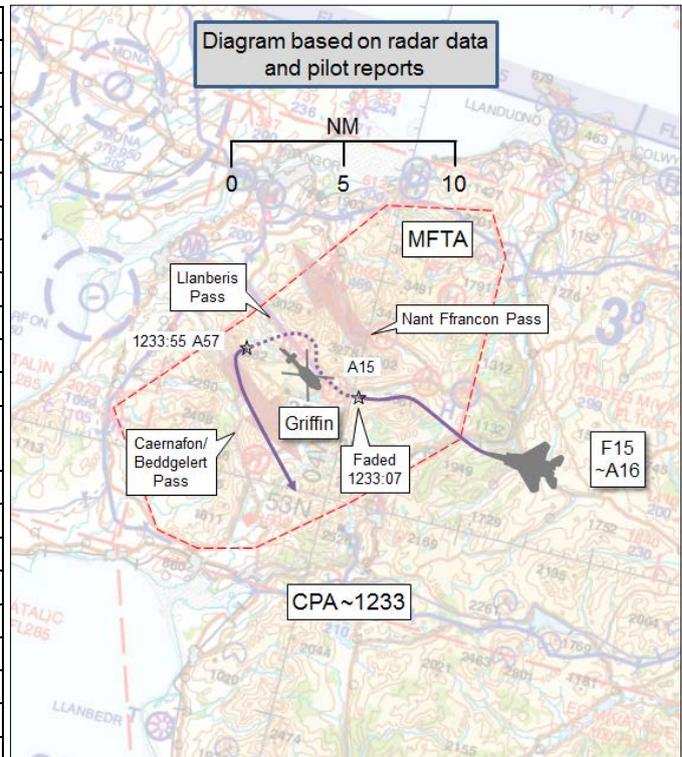
Recorded	Aircraft 1	Aircraft 2
Aircraft	Griffin	F15
Operator	HQ Air (Trg)	Foreign Mil
Airspace	London FIR	London FIR
Class	G	G
Rules	VFR	VFR
Service	Listening Out	Listening Out
Provider	Valley Low Level	LL Common
Altitude/FL	NK	NK
Transponder	A, C, S	A, C, S
<b>Reported</b>		
Colours	Black, yellow	Dark grey
Lighting	Nav, tail, upper and lower HISL	Nav
Conditions	VMC	VMC
Visibility	40km	'Unrestricted'
Altitude/FL	NK	1000-2000ft
Altimeter	NK (1015hPa)	agl (1014hPa)
Heading	120°	300°
Speed	N/A	440kt
ACAS/TAS	TAS	Not fitted
Alert	TA	N/A
<b>Separation</b>		
Reported	100ft V/400m H	200ft V/0.5nm H
Recorded	NK

**THE GRIFFIN PILOT** reports conducting a mountain-flying workup sortie. As the handling pilot (HP) was presenting his demonstration of a particular exercise, the TAS alert sounded, informing them of traffic in the 12 o'clock at less than a mile. They looked to see an F15 entering the valley and closing rapidly. The HP took immediate evasive action with a hard turn to remain tight against the valley side. The F15 passed down their left-hand side, slightly below and at a distance estimated visually as 400 metres. The Griffin pilot noted that the TAS contact occurred at less than a mile, as the F15 unmasked from terrain. The Griffin pilot contacted Valley approach to inform them of the Airprox.

**THE F15 PILOT** reports turning down the valley in a right-hand turn when he saw a black and yellow helicopter on the left, slightly high and at a range of 3nm. He turned hard right and climbed to increase separation.
