AIRPROX REPORT No 2017162

Date: 13 Jul 2017 Time: 1322Z Position: 5138N 00113W Location: 10nm S Oxford airport

PART A: SUMMARY OF INFORMATION REPORTED TO UKAB

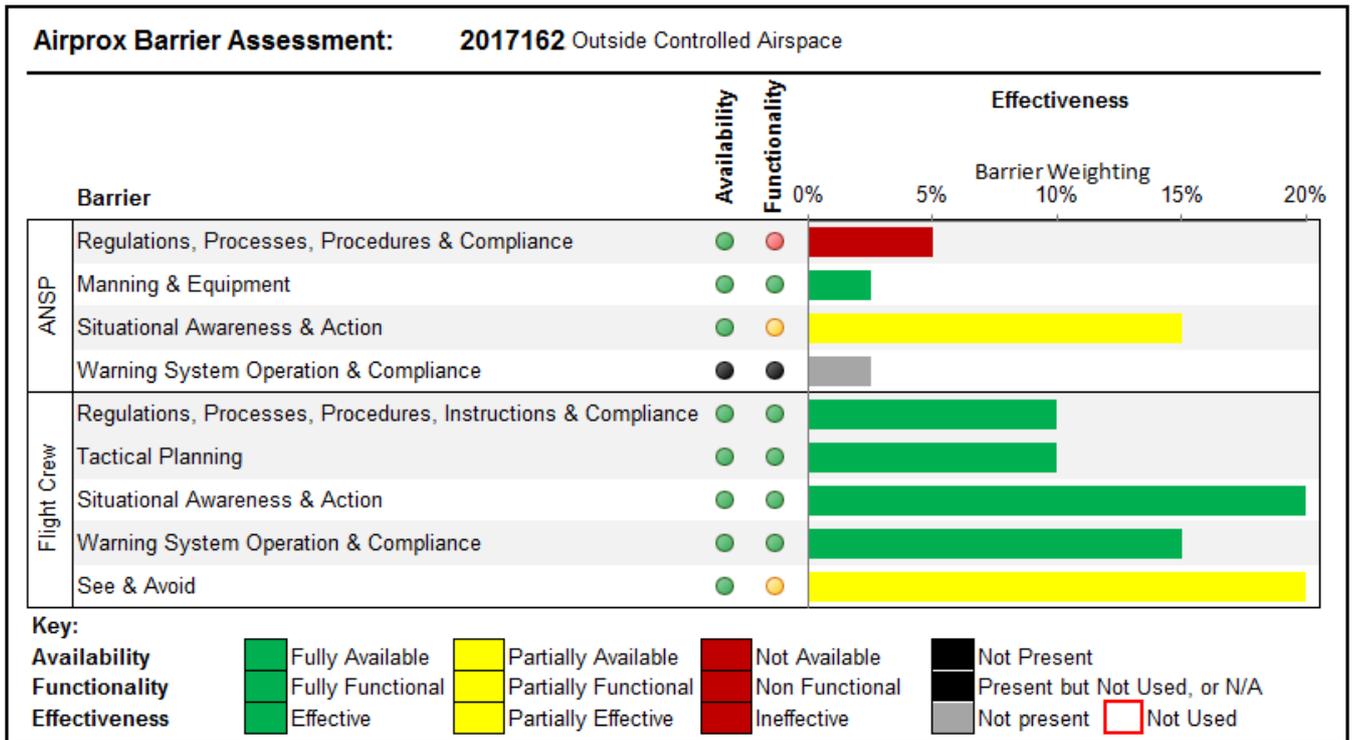
Flight Crew:

See and Avoid was **partially effective** because both pilots obtained only a late sighting of the other aircraft and were only able to take late avoiding action.
