AIRPROX REPORT No 2017208

Date: 25 Aug 2017 Time: 1500Z Position: 5135N 00052W Location: 3nm SW Booker

PART A: SUMMARY OF INFORMATION REPORTED TO UKAB

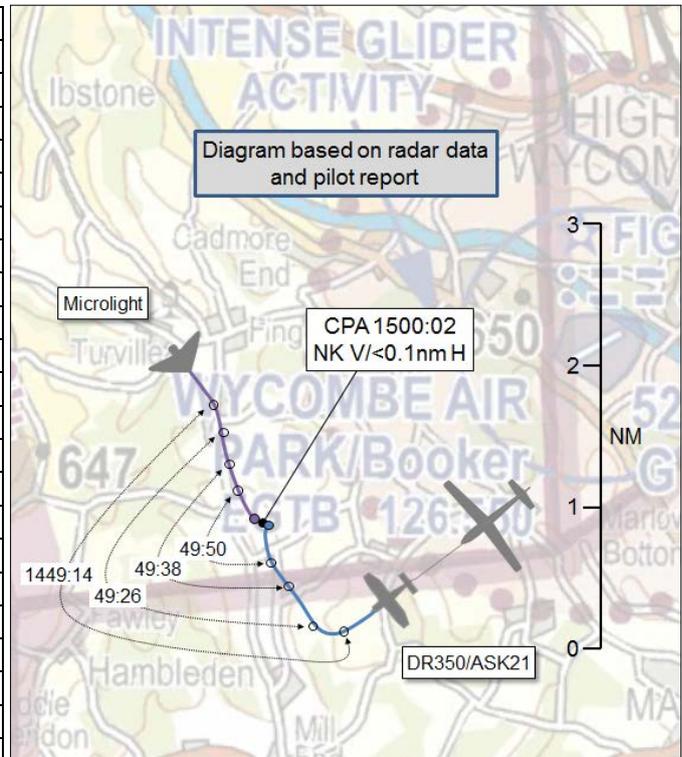
Recorded	Aircraft 1	Aircraft 2
Aircraft	Robin DR350	Microlight
Operator	Civ Club	Unknown
Airspace	London FIR	London FIR
Class	G	G
Rules	VFR	
Service	None	
Provider	N/A	
Altitude/FL	NK	
Transponder	Not fitted	
Reported		Not reported
Colours	White/blue/red	
Lighting	Strobe	
Conditions	VMC	
Visibility	20km	
Altitude/FL	1950ft	
Altimeter	QFE (NK hPa)	
Heading	300°	
Speed	70kt	
ACAS/TAS	PowerFLARM	
Alert	None	
Separation		
Reported	0ft V/150m H	NK
Recorded	NK V/<0.1nm H
