**AIRPROX REPORT No 2017277**

Date: 14 Dec 2017 Time: 1514Z Position: 5139N 00101W Location: 4nm NE RAF Benson

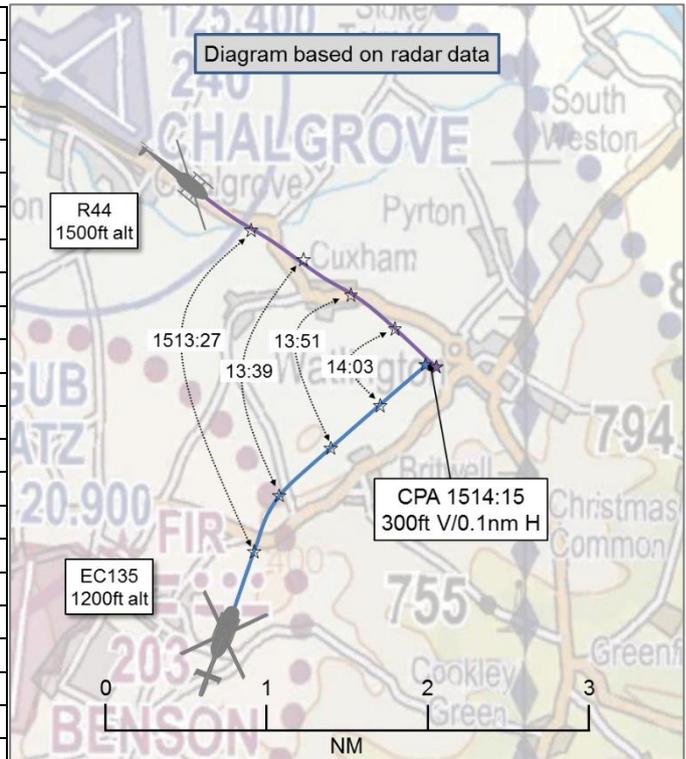
Recorded	Aircraft 1	Aircraft 2
Aircraft	EC135	R44
Operator	Civ Comm	Civ Pte
Airspace	London FIR	London FIR
Class	G	G
Rules	VFR	VFR
Service	Basic	Basic
Provider	Benson Zone	Benson Zone
Altitude/FL	1200ft	1500ft
Transponder	A, C, S	A, C
<b>Reported</b>		
Colours	Red	Red
Lighting	HISL, nav	Strobes, position
Conditions	VMC	VMC
Visibility	40km	15km
Altitude/FL	1200ft	1300ft
Altimeter	QNH (988hPa)	QNH (NK hPa)
Heading	020°	155°
Speed	120kt	110kt
ACAS/TAS	Not fitted	Not fitted
<b>Separation</b>		
Reported	200ft V/0m H	Seen after CPA
Recorded	300ft V/0.1nm H
