AIRPROX REPORT No 2017047

Date: 02 Apr 2017 Time: 1358Z Position: 5131N 00215W Location: Halfpenny Green (elev 283ft)

PART A: SUMMARY OF INFORMATION REPORTED TO UKAB

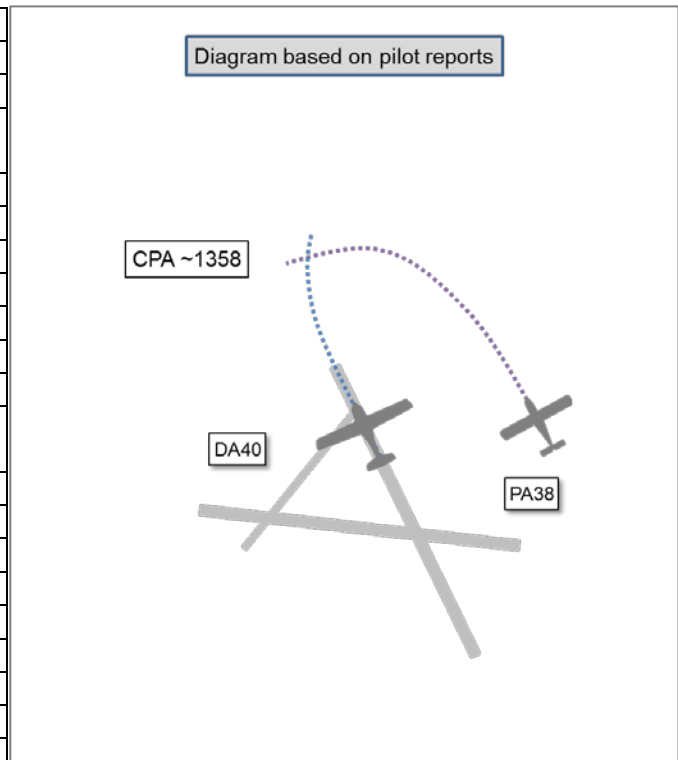
Recorded	Aircraft 1	Aircraft 2
Aircraft	DA40	PA38
Operator	Civ Pte	Civ Trg
Airspace	Halfpenny Green ATZ	Halfpenny Green ATZ
Class	G	G
Rules	VFR	VFR
Service	Information	Information
Provider	Halfpenny Green	Halfpenny Green
Altitude/FL	NK	NK
Transponder	A, C, S	A only
Reported		
Colours	White, black, gold	White, blue
Lighting	Strobes, taxi	NK
Conditions	VMC	VMC
Visibility	NK	10km
Altitude/FL	700ft	1300ft
Altimeter	QNH (1023hPa)	QFE (NK hPa)
Heading	070° (right turn)	260°
Speed	70kt	90kt
ACAS/TAS	Not fitted	Not fitted
Separation		
Reported	15ft V/100m H	200ft V//¼nm H
Recorded	NK

THE DA40 PILOT reports departing from Halfpenny Green. He had received and acknowledged a ‘Take off at your discretion’ call and was visual with a PA28 preceding him departing RW34 which, as reported by the FISO, turned left and was not a factor. No other traffic was in sight at the start of or during his takeoff. Before starting a gentle right turn, he looked out to check the airspace was clear, noted that he would not pass directly above some farm buildings, and commenced the turn. As he lowered the right wing, the conflicting aircraft became visible below in a left turn, and then rapidly disappeared from sight just below and behind. Once he had stabilised on course, retracted flap, and considered what he had seen, he called the FISO and made an Airprox report on R/T. The DA40 pilot reported that after landing at his destination he telephoned to follow up his initial R/T report and was told that the only candidate aircraft the FISO saw was observed to be at normal circuit height. The DA40 pilot noted that he could only speculate that the conflicting aircraft might have been intending to join crosswind from the deadside, but that the very low height suggests that height control by the conflicting aircraft's commander may not have been of the best.

THE PA38 PILOT reports conducting an overhead join at Halfpenny Green for RW34 left-hand circuit. He had descended on the deadside to 1300ft and was about to enter the crosswind leg for RW34 when a departing aircraft made a ‘non-standard and unauthorised’ right-hand turnout.
