AIRPROX REPORT No 2018010

Date: 22 Jan 2018 Time: 1930Z Position: 5058N 00256W Location: Merryfield airfield

PART A: SUMMARY OF INFORMATION REPORTED TO UKAB

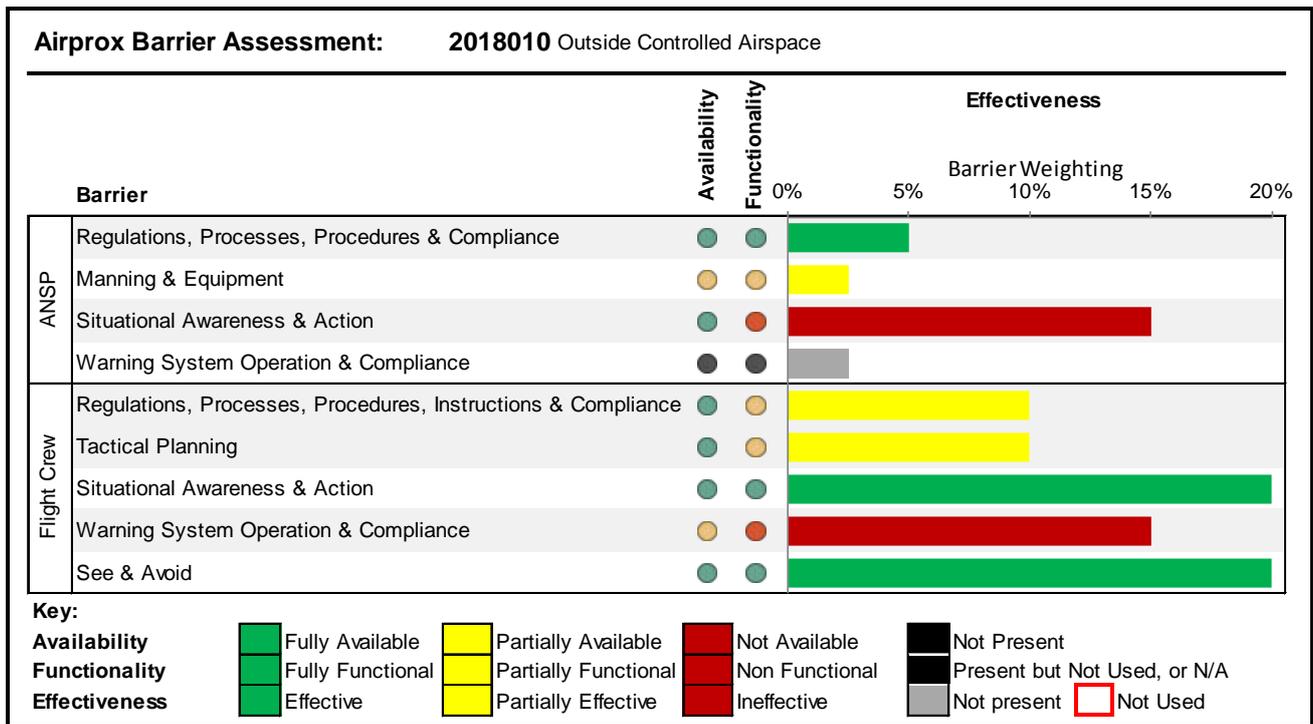
Safety Barrier Assessment⁶

Warning System Operation and Compliance were assessed as **ineffective** because the Merlin pilot had deselected his TAS due to circuit traffic setting off warnings. The Wildcat pilot did not report receiving any warning.
