AIRPROX REPORT No 2018025

Date: 21 Feb 2018 Time: 1556Z Position: 5232N 00218W Location: 1.5nm W Halfpenny Green

PART A: SUMMARY OF INFORMATION REPORTED TO UKAB

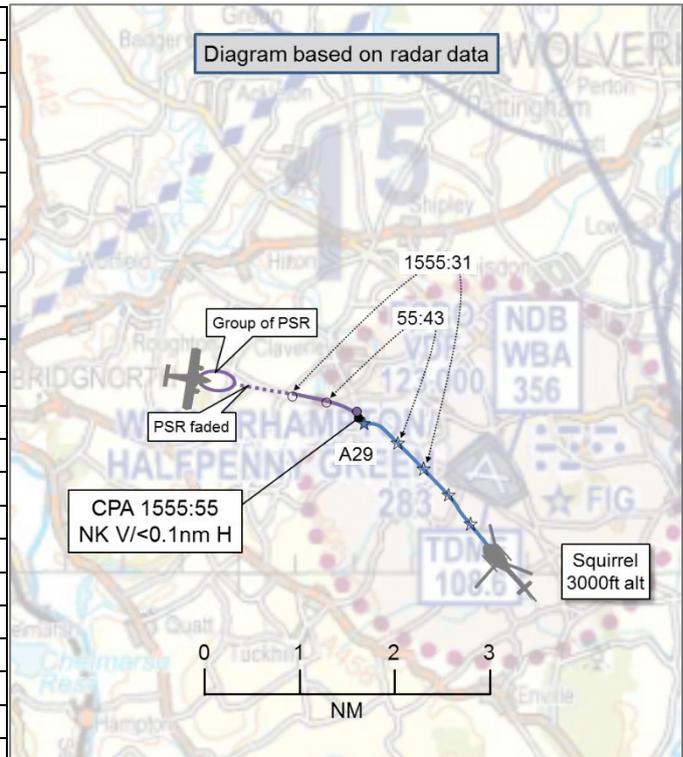
Recorded	Aircraft 1	Aircraft 2
Aircraft	Squirrel	Light aircraft
Operator	HQ Air (Trg)	Unknown
Airspace	London FIR	London FIR
Class	G	G
Rules	VFR	NK
Service	None ¹	NK
Provider	(Brize LARS)	NK
Altitude/FL	2900ft	NK
Transponder	A, C, S	PSR only
Reported		Not reported
Colours	Yellow, black	
Lighting	NK	
Conditions	VMC	
Visibility	20km	
Altitude/FL	3000ft	
Altimeter	QNH (1026hPa)	
Heading	329°	
Speed	120kt	
ACAS/TAS	TAS	
Alert	None	
Separation		
Reported	50ft V/150ft H	NK
Recorded	NK V/<0.1nm H

THE SQUIRREL INSTRUCTOR reports that he was seated in the left seat, giving IF instruction to an IF-visor equipped student in the right seat. The LHS QHI saw a white and blue low-wing twin-propeller aircraft in the 10:30 position at a range of about 300m on an approximately steady bearing. Control was immediately taken and, having observed no reaction from the other aircraft, a left descending turn commenced through approximately 40° and 50ft. A left turn was initiated because a right turn would have required a longer turn to achieve deconfliction and placed the conflicting aircraft into a blind spot. Shortly after commencing the left-turn, the other aircraft was seen to turn to the right briefly before levelling its wings and continuing on track. The Squirrel crew had been receiving a Traffic Service from Brize Radar and, although communication between Brize Radar and another aircraft had been heard shortly before, had unwittingly flown out of R/T coverage, thereby denying any form of Service. The QHI commented that rear-seat crew members were also looking out, primarily for 2 TAS contacts (not indicating as a threat) in the forward left and right quadrants. The late sighting of the conflicting aircraft was assumed to be due to a combination of constant relative bearing and its light colour scheme blending into the white cloud background and hazy visibility. Aggravating factors were a lack of TAS alert from the Airprox aircraft, unwittingly leaving Brize Radar R/T coverage and the instructional task delaying an earlier change of ATS provider.
