AIRPROX REPORT No 2018031

Date: 07 Feb 2018 Time: 1045Z Position: 5228N 00020E Location: 9nm NW Mildenhall

PART A: SUMMARY OF INFORMATION REPORTED TO UKAB

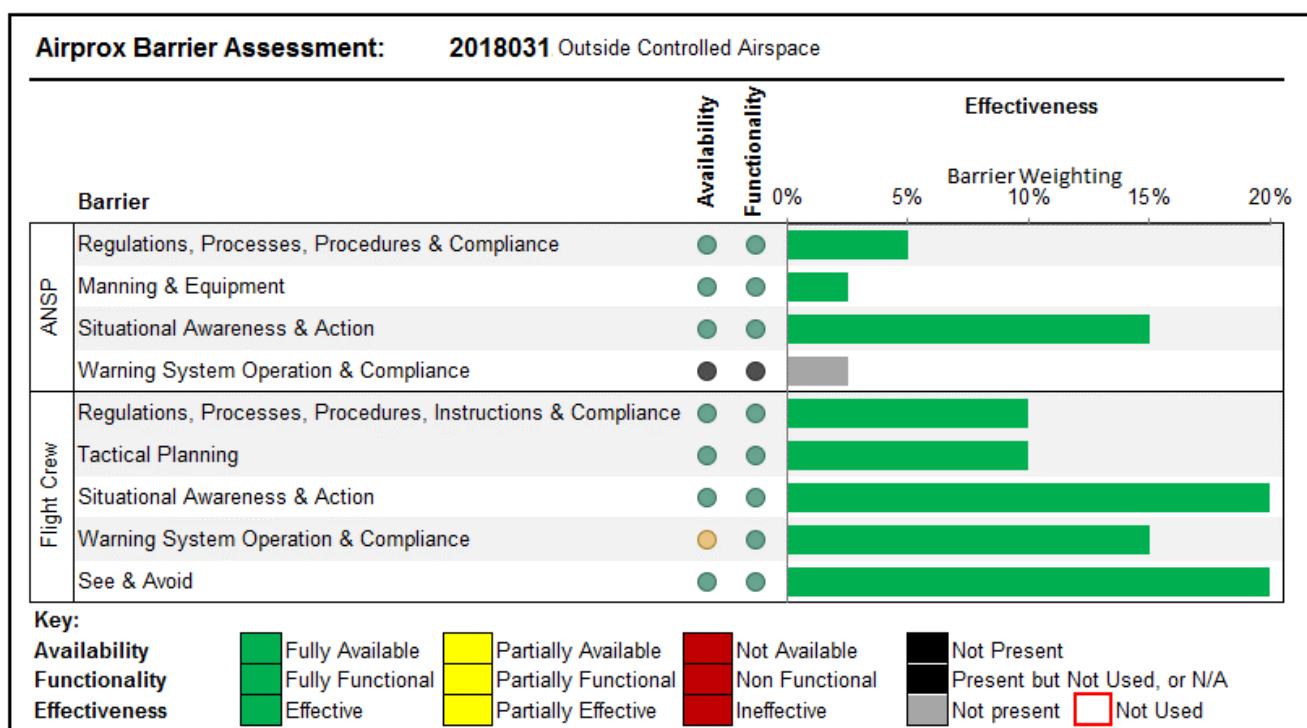
Warning System Operation and Compliance were assessed as partially available because the F15s did not have an electronic collision warning system. Nevertheless, the barrier was fully effective in that the RC135 was able to react to the F15s.
