AIRPROX REPORT No 2018046

Date: 08 Apr 2018 Time: 1331Z Position: 5612N 00326W Location: Kinross

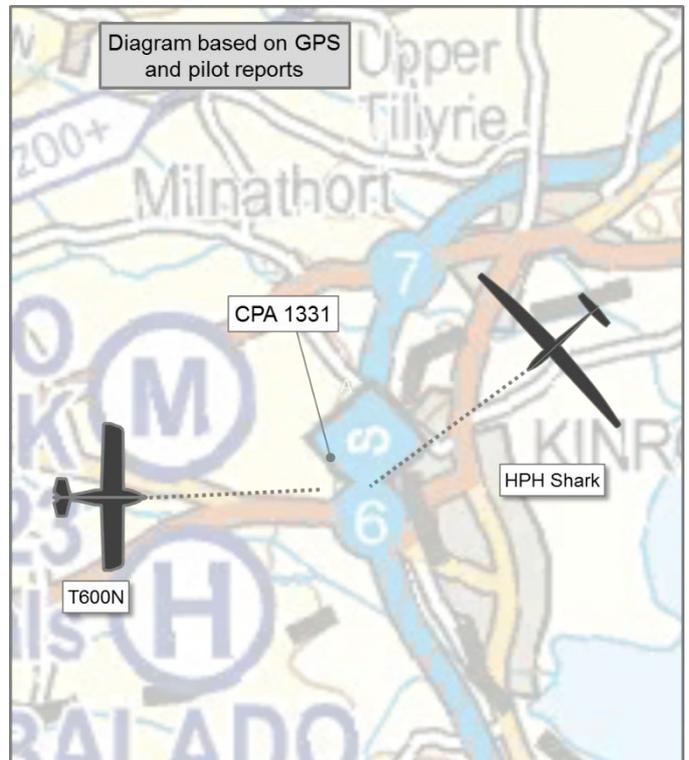
THE T600N PILOT reports that he had just taken-off with a student and was listening out on Safety Comm. They were intending to climb to a circuit height of 1500ft and depart to the west from the overhead. He was still climbing at the end of the downwind leg and turning onto 'base' when a glider suddenly appeared immediately ahead, no more than 30-50m away. He rolled hard to port and the glider appeared to push hard forward into a dive. The glider passed slightly below and within about 10m to the starboard. He tried to remain visual with it to see where it had gone but lost sight of it, so he routed back to the airfield where he circled and contacted the ground station. The radio happened to be manned by a retired ATCO, who then checked Flightradar24 and found the callsign of the glider. He commented that Balado airfield was marked on the aviation charts, yet still gliders kept flying through the circuit without radio contact.

THE HPH SHARK PILOT reports that he was flying south-west of Kinross after not finding any lift over Kinross. He did a general scan, then began the procedures for starting his glider's sustainer engine. After the engine had deployed and he had ascertained that it was in the up position, he continued with starting it. At this point he did another general scan and was very surprised to see a powered aircraft in the 2 o'clock position, heading east and at the same level. He promptly put the glider into a dive and banked away from the other aircraft. There was no FLARM warning for the incident, so he assumed the micro-light was not FLARM equipped.
