AIRPROX REPORT No 2021088

Date: 13 Jun 2021 Time: 1112Z Position: 5134N 00042E Location: Southend CTR

PART A: SUMMARY OF INFORMATION REPORTED TO UKAB

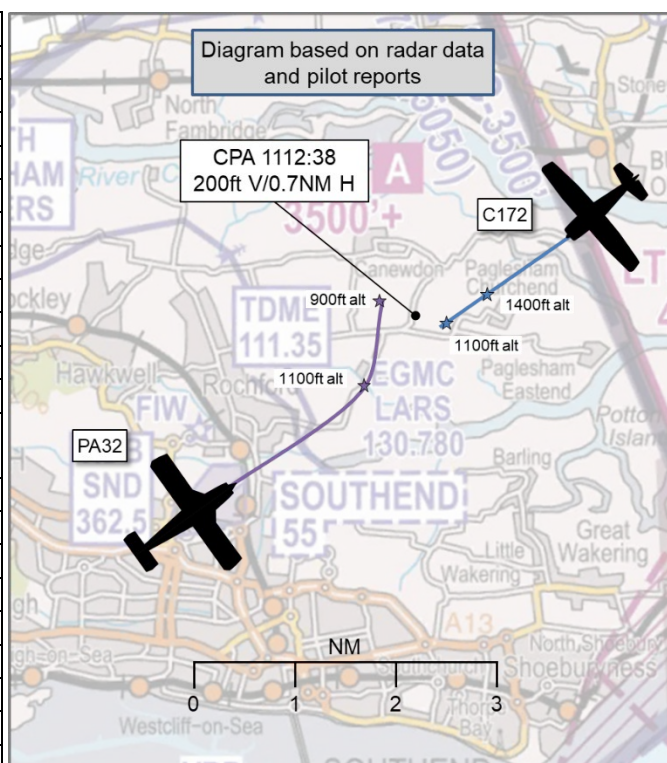
THE SOUTHEND CONTROLLER reported that the PA32 was in the right-hand circuit for RW23 and the pilot reported downwind. The C172 was inbound on the ILS for RW23. The PA32 was observed to position from downwind to the Southend overhead, exceeding their circuit clearance height, they were asked to confirm if they were positioning downwind. The PA32 is then observed to fly NE up the final approach directly towards the C172 ILS traffic on final. The PA32 pilot was given instructions to turn away from final approach which they appeared not to adhere to. Both aircraft were considered to be very close to each other on the final approach. The controller considered this was an Airprox situation.
