AIRPROX REPORT No 2021079

Date: 10 Jun 2021 Time: 1530Z Position: 5308N 00238W Location: 2NM south Oulton Park VRP

PART A: SUMMARY OF INFORMATION REPORTED TO UKAB

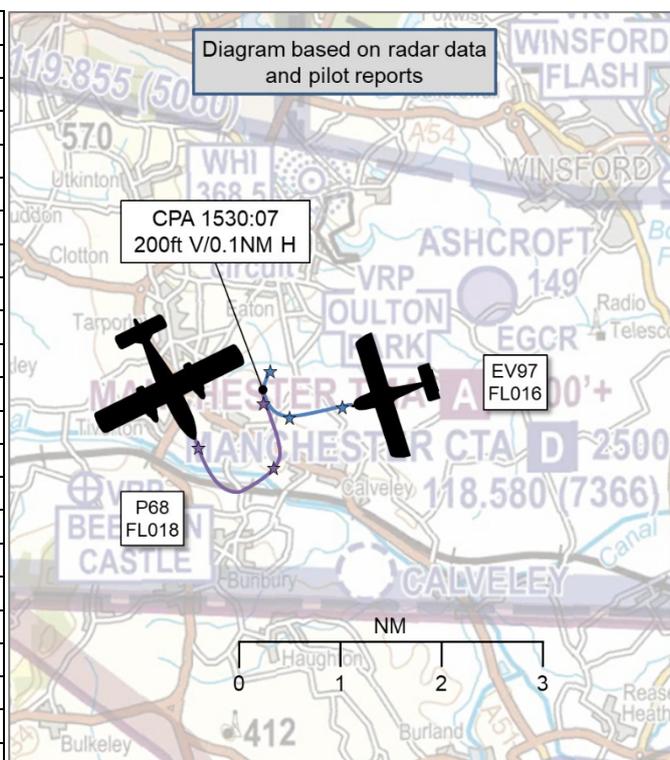
THE EV97 INSTRUCTOR reports that they were conducting dual training involving several turns and advance manoeuvres in the location of the Airprox. They and their student first spotted the P68 at a range of about 2NM to the southwest, at which time it was not converging on them. Less than 30sec later they noticed the P68 turning towards them. The instructor took control and instigated several steep rolls to make them more visible. This action didn't appear to stop the P68 continuing to converge. The EV97 instructor then changed course two or three times; each time to ensure they maximised the separation. At no point did it seem the P68 had seen them. When separation eventually became safe, they set course for Hawksview (adjacent to Stretton) via the Manchester LLR. They contacted Manchester Radar to ask if they were in contact with the P68, Manchester ATCO advised them it was communicating with Liverpool. They remained on frequency with Manchester Radar who provided them with a Radar Control service to enter the Zone for landing at Hawksview. On landing at Hawksview they telephoned Liverpool ATC and spoke with the controller who was communicating with the P68 at the time of the Airprox. The controller advised them that they had made the P68 pilot aware of their presence and confirmed the P68 pilot acknowledged and said they were looking out for them.
