**AIRPROX REPORT No 2021081**

Date: 14 Jun 2021 Time: 1332Z Position: 5135N 00043W Location: Marlow

**PART A: SUMMARY OF INFORMATION REPORTED TO UKAB**

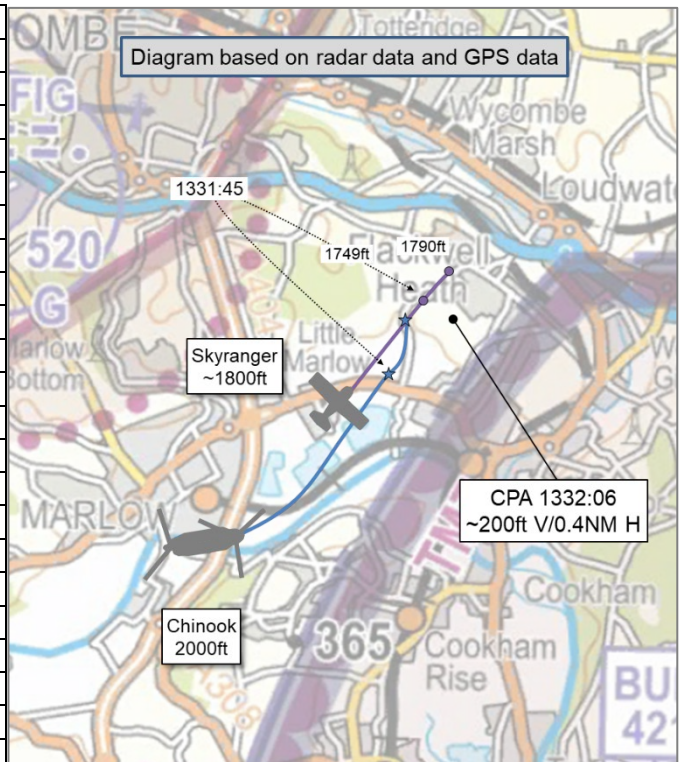
Recorded	Aircraft 1	Aircraft 2
Aircraft	Chinook	Skyranger
Operator	HQ JHC	Civ FW
Airspace	London FIR	London FIR
Class	G	G
Rules	VFR	VFR
Service	Basic	None
Provider	Heathrow SVFR	
Altitude/FL	2000ft	1790ft
Transponder	A, C, S	Not fitted
<b>Reported</b>		
Colours	Green	White
Lighting	Nav, HISLs	None
Conditions	VMC	VMC
Visibility	>10km	5-10km
Altitude/FL	2000ft	1800ft
Altimeter	QNH (1020hPa)	QNH
Heading	270°	030°
Speed	120kt	75kt
ACAS/TAS	TAS	PilotAware
Alert	None	None
<b>Separation</b>		
Reported	2-500ft V/0m H	Not Seen
Recorded	~200ft V/0.4NM H
